ANNUAL REPORT FOR 2012

**Unnamed Tributary to Lumber
River Mitigation Site
Robeson County
TIP No. R-0513WM
COE Action ID: 2003-00999**

Prepared By:
Natural Environment Section & Roadside Environmental Unit
North Carolina Department of Transportation
December 2012

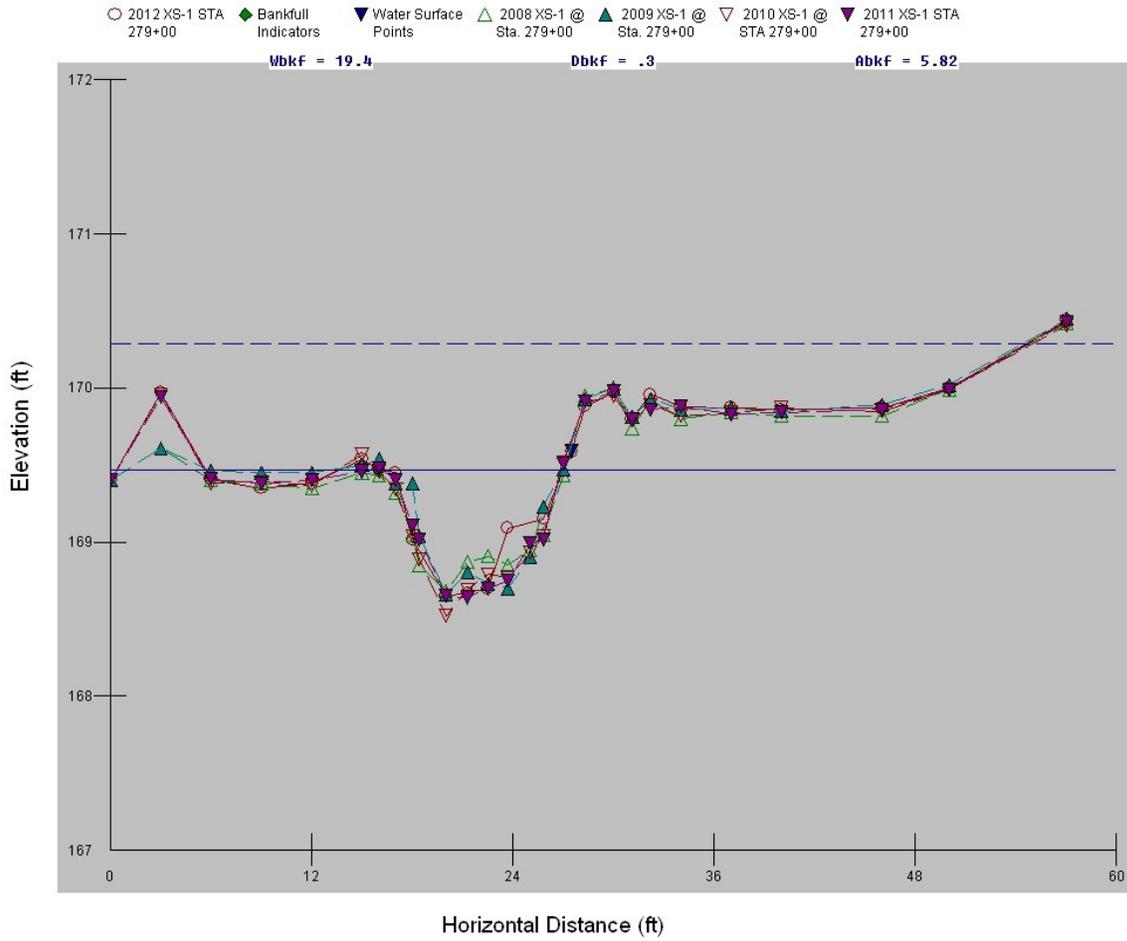
UT to Lumber River XS-1 STA 279+00

Cross-Section #1 (Riffle) Abbreviated Morphological Summary					
	2008	2009	2010	2011	2012
Bankfull Width (ft)	11.0	11.20	10.90	10.93	11.04
Bankfull Mean Depth (ft)	0.45	0.54	0.55	0.54	0.47
Width/Depth Ratio	24.44	20.74	19.73	20.24	23.49
Bankfull Cross Sectional Area (ft ²)	4.98	6.03	5.92	5.86	5.13
Maximum Bankfull Depth (ft)	0.75	0.88	0.94	0.84	0.82
Width of the Floodprone Area (ft)	53	56	56.83	55.25	54.61
Entrenchment Ratio	4.83	5.05	5.24	5.06	4.95

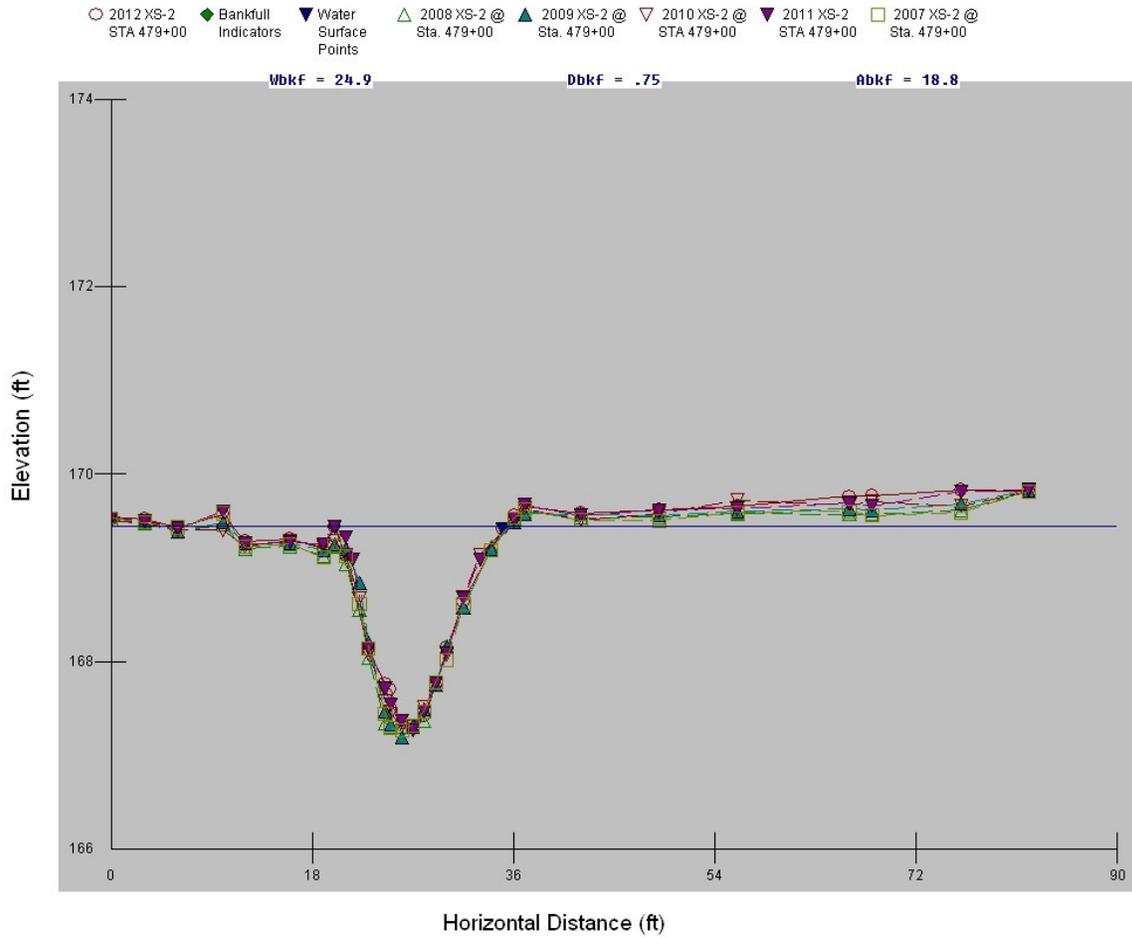
UT to Lumber River XS-2 STA 479+00

Cross-Section #2 (Pool) Abbreviated Morphological Summary*					
	2008	2009	2010	2011	2012
Bankfull Cross Sectional Area (ft²)	15.31	15.05	15.12	16.89	17.45
Maximum Bankfull Depth (ft)	1.92	2.06	1.97	2.17	2.16
Bankfull Mean Depth (ft)	1.09	0.84	1.06	1.09	1.15
Bankfull Width (ft)	14.0	17.92	14.25	15.44	15.2

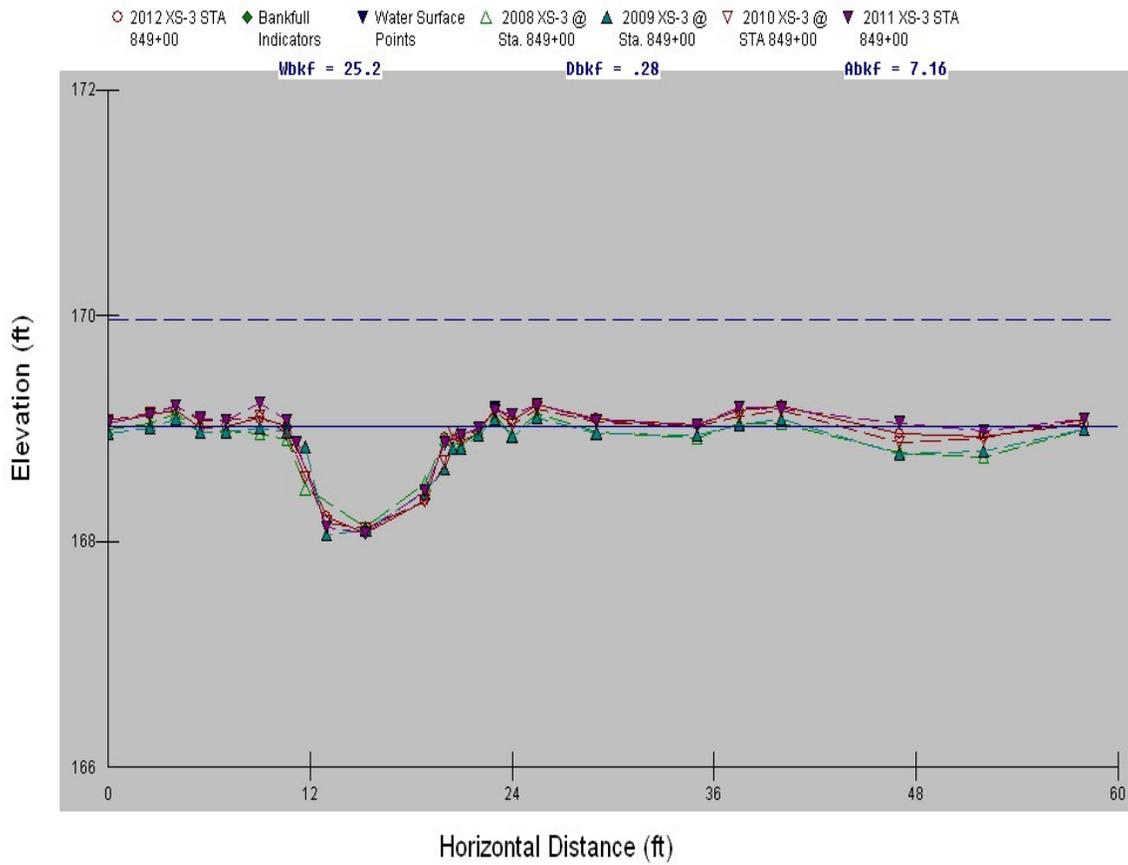
UT to Lumber River XS-3 STA 849+00

Cross-Section #3 (Riffle) Abbreviated Morphological Summary					
	2008	2009	2010	2011	2012
Bankfull Width (ft)	9.4	11.40	13.71	11.4	11.69
Bankfull Mean Depth (ft)	0.49	0.53	0.57	0.61	0.55
Width/Depth Ratio	19.18	21.51	24.05	18.69	21.25
Bankfull Cross Sectional Area (ft²)	4.64	6.06	7.87	6.91	6.45
Maximum Bankfull Depth (ft)	0.77	0.91	1.00	1	0.94
Width of the Floodprone Area (ft)	58	58	58	58	58
Entrenchment Ratio	6.17	5.09	4.23	5.09	4.96

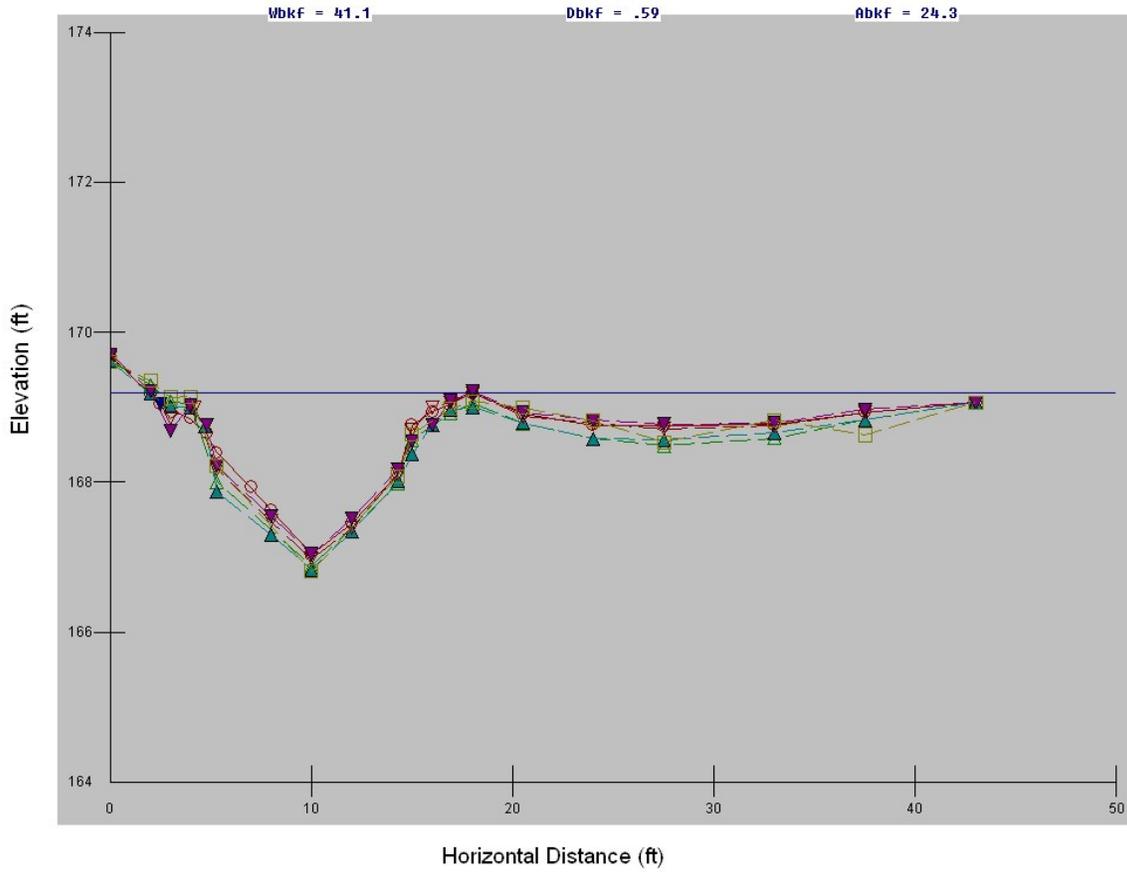
UT to Lumber River XS-4 STA 964+00

Cross-Section #4 (Pool) Abbreviated Morphological Summary*					
	2008	2009	2010	2011	2012
Bankfull Cross Sectional Area (ft²)	16.42	17.90	17.16	17.16	16.23
Maximum Bankfull Depth (ft)	2.17	2.29	2.21	2.17	2.15
Bankfull Mean Depth (ft)	1.17	1.28	1.08	1.07	1.01
Bankfull Width (ft)	14.0	14.0	15.92	15.98	16.08

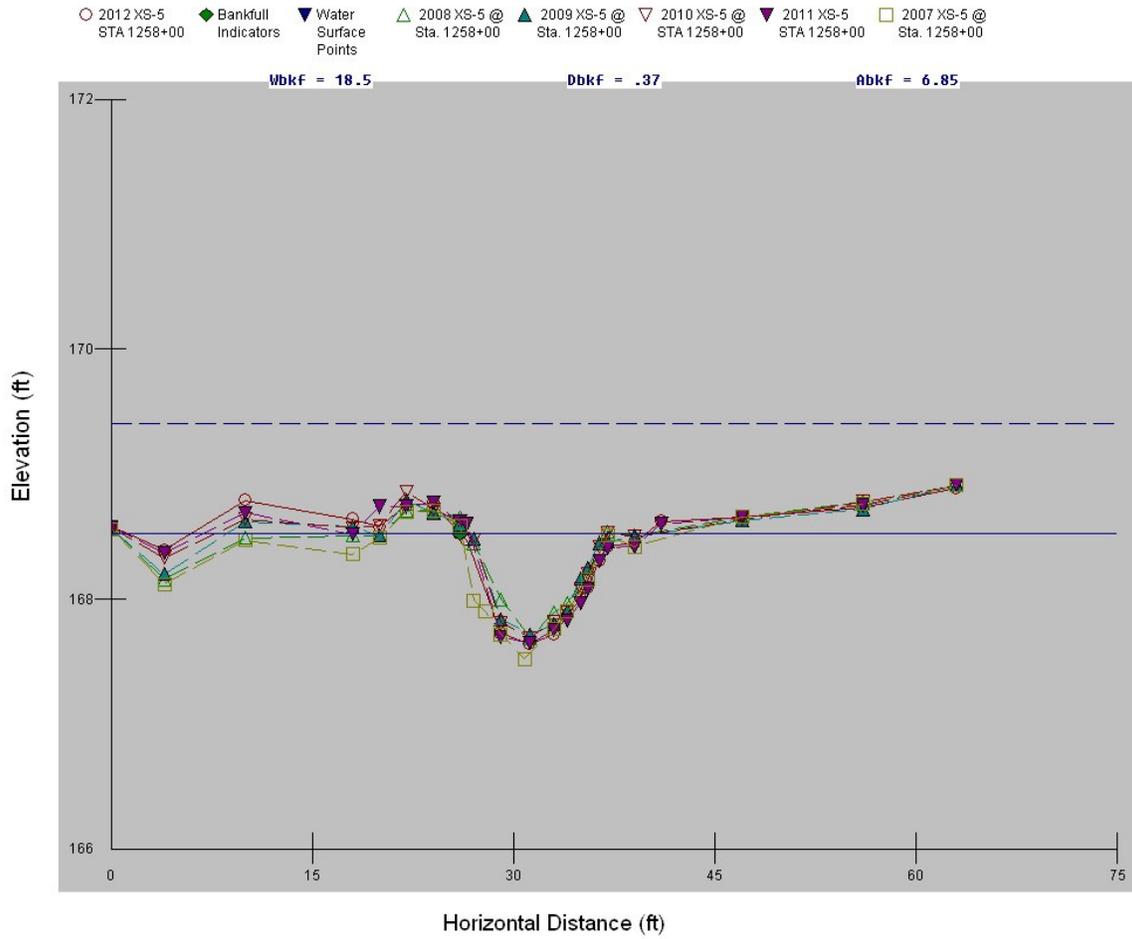
UT to Lumber River XS-5 STA 1258+00

Cross-Section #5 (Riffle) Abbreviated Morphological Summary					
	2008	2009	2010	2011	2012
Bankfull Width (ft)	10.45	9.31	11.00	11.00	11.00
Bankfull Mean Depth (ft)	0.49	0.49	0.59	0.66	0.66
Width/Depth Ratio	21.33	19.0	18.64	16.67	16.67
Bankfull Cross Sectional Area (ft ²)	5.11	4.52	6.51	7.3	7.3
Maximum Bankfull Depth (ft)	0.85	0.73	0.93	0.97	0.97
Width of the Floodprone Area (ft)	63	63	63	63	63
Entrenchment Ratio	6.03	6.77	5.73	5.73	5.73

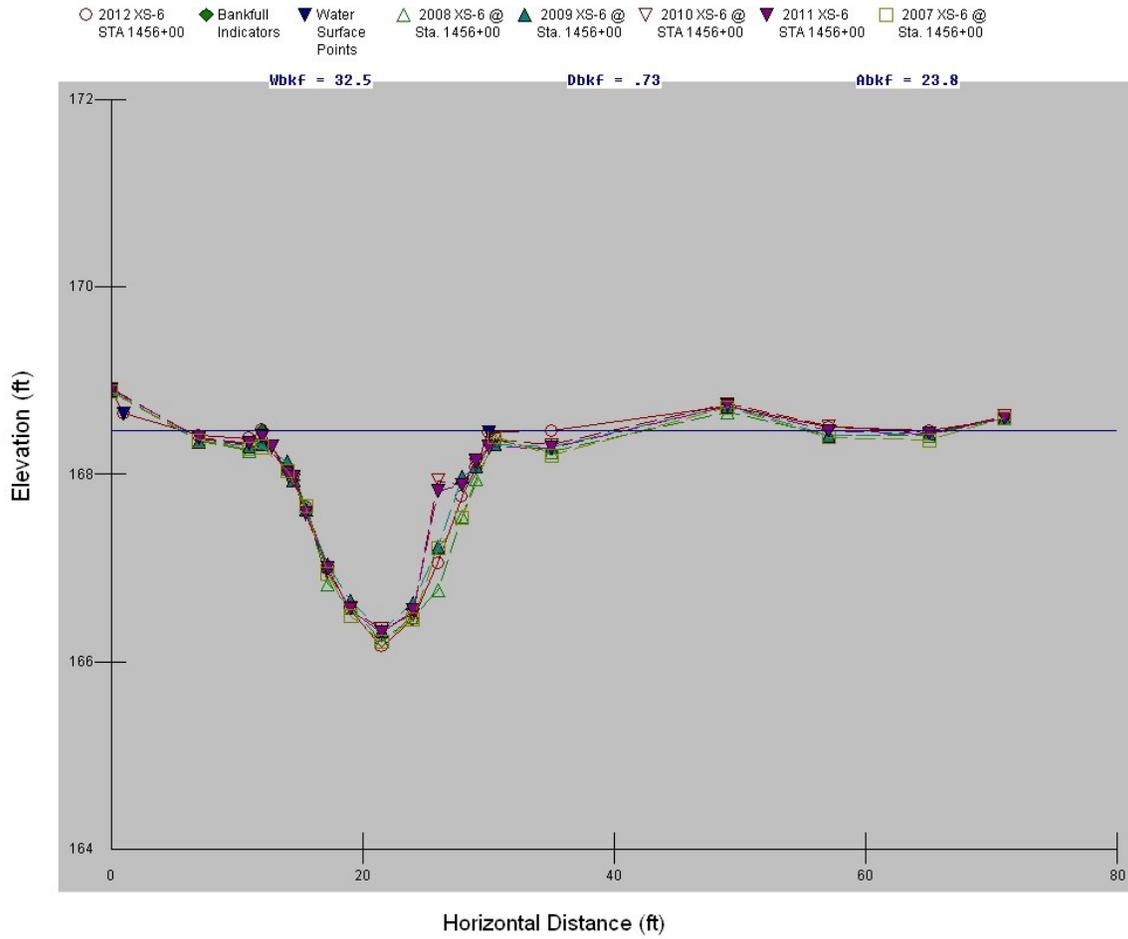
UT to Lumber River XS-6 STA 1456+00

Cross-Section #6 (Pool) Abbreviated Morphological Summary*					
	2008	2009	2010	2011	2012
Bankfull Cross Sectional Area (ft ²)	22.71	19.06	19.54	20.06	23.32
Maximum Bankfull Depth (ft)	2.15	1.99	2.03	2.1	2.31
Bankfull Mean Depth (ft)	1.23	1.03	1.06	1.07	1.3
Bankfull Width (ft)	18.50	18.50	18.45	18	18

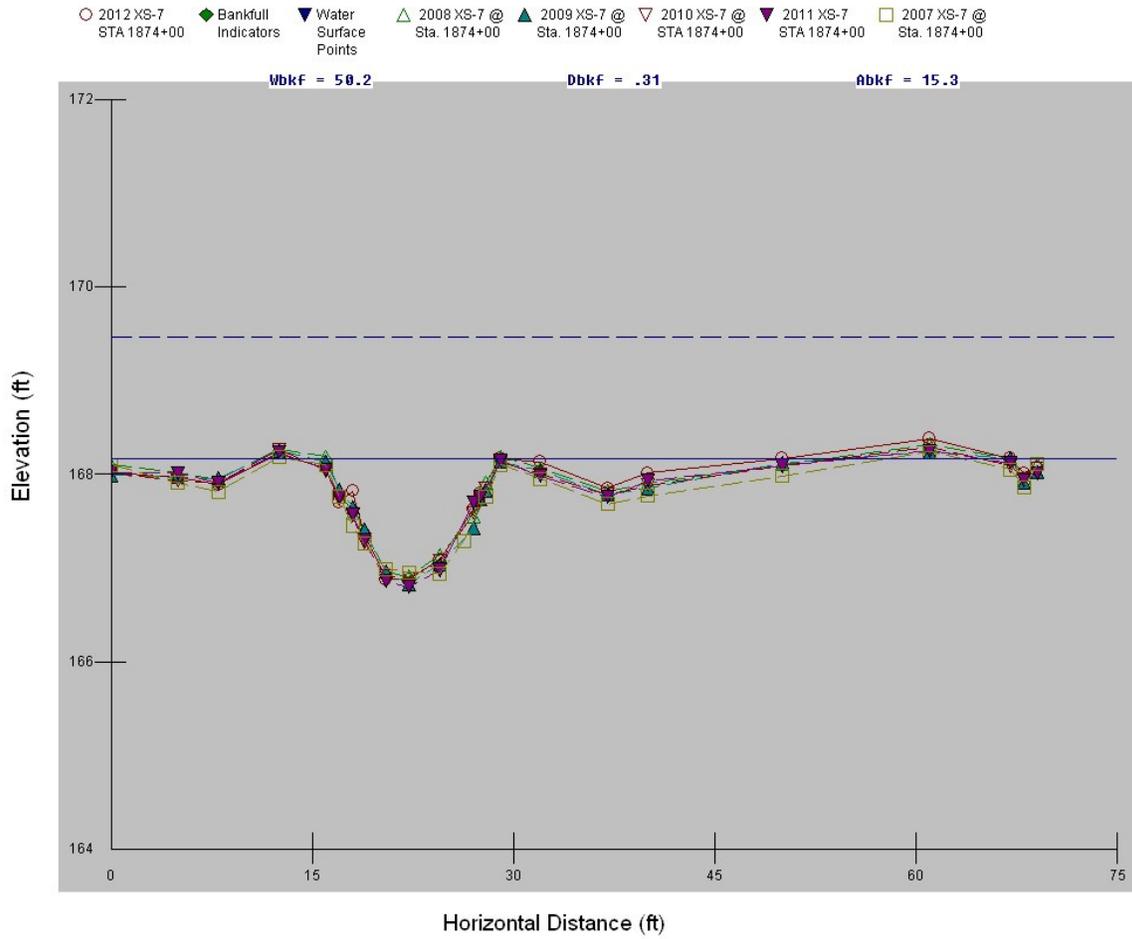
UT to Lumber River XS-7 STA 1874+00

Cross-Section #7 (Riffle) Abbreviated Morphological Summary					
	2008	2009	2010	2011	2012
Bankfull Width (ft)	13.0	13.0	12.8	13	13
Bankfull Mean Depth (ft)	0.8	0.79	0.75	0.82	0.8
Width/Depth Ratio	16.25	16.46	17.07	15.85	16.25
Bankfull Cross Sectional Area (ft ²)	10.4	10.26	9.66	10.63	10.36
Maximum Bankfull Depth (ft)	1.28	1.30	1.19	1.34	1.29
Width of the Floodprone Area (ft)	69	69	69	69	69
Entrenchment Ratio	5.31	5.31	5.39	5.31	5.31

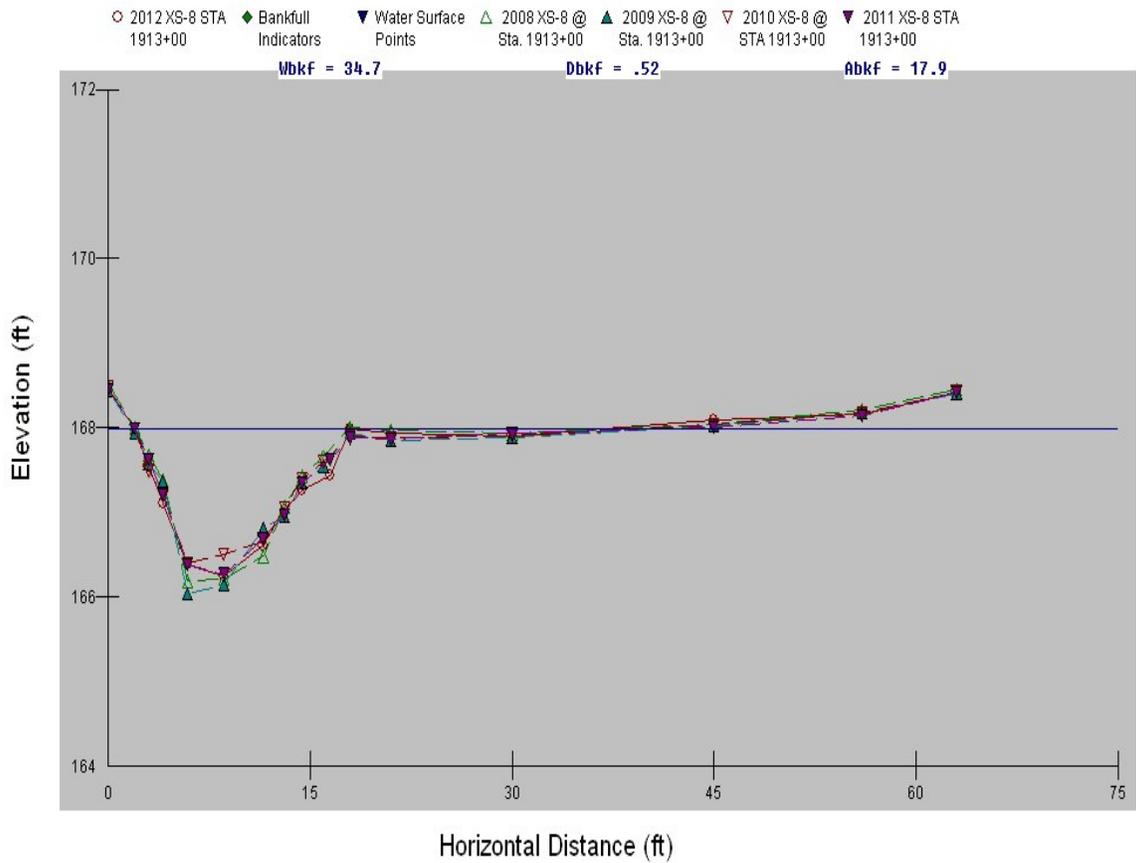
UT to Lumber River XS-8 STA 1913+00

Cross-Section #8 (Pool) Abbreviated Morphological Summary*					
	2008	2009	2010	2011	2012
Bankfull Cross Sectional Area (ft²)	16.5	16.01	14.56	14.43	16.95
Maximum Bankfull Depth (ft)	1.81	1.90	1.54	1.61	1.74
Bankfull Mean Depth (ft)	1.03	1.0	0.92	0.92	1.06
Bankfull Width (ft)	16	16	15.9	15.69	16.04

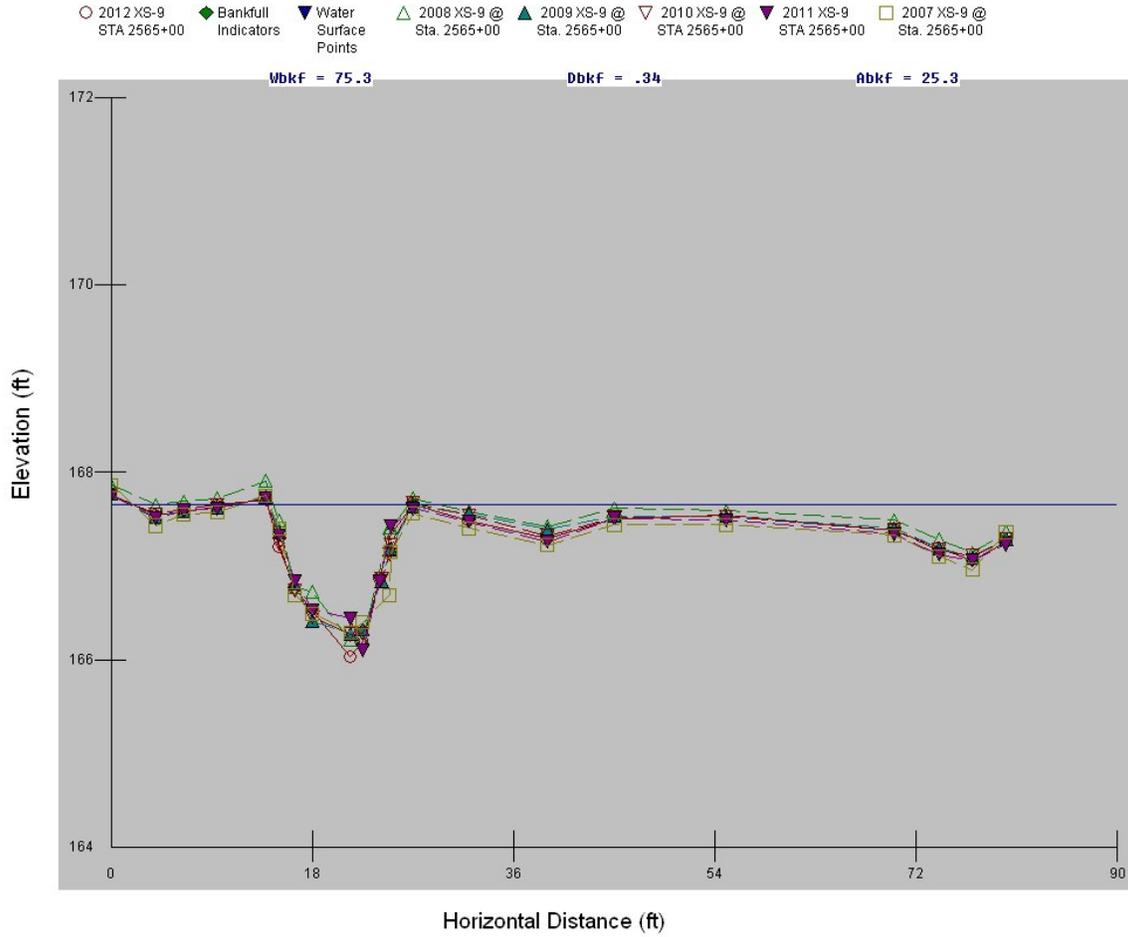
UT to Lumber River XS-9 STA 2565+00

Cross-Section #9 (Pool) Abbreviated Morphological Summary*					
	2008	2009	2010	2011	2012
Bankfull Cross Sectional Area (ft²)	10.89	11.15	11.74	10.01	11.81
Maximum Bankfull Depth (ft)	1.51	1.36	1.40	1.51	1.63
Bankfull Mean Depth (ft)	0.86	0.87	0.90	0.78	0.9
Bankfull Width (ft)	12.61	12.88	13.10	12.86	13.06

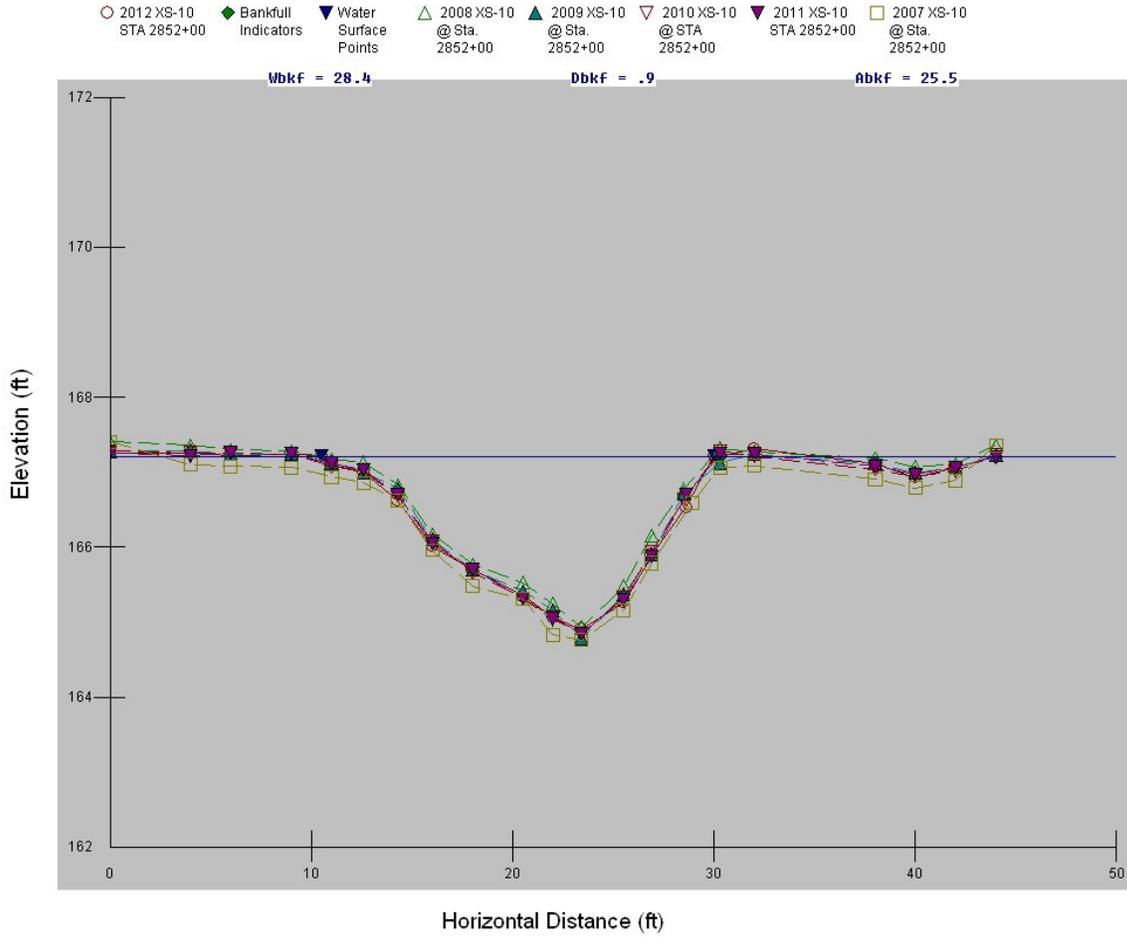
UT to Lumber River XS-10 @ STA 2852+00

Cross-Section #10 (Pool) Abbreviated Morphological Summary*					
	2008	2009	2010	2011	2012
Bankfull Cross Sectional Area (ft²)	23.31	21.96	23.56	24.81	24.42
Maximum Bankfull Depth (ft)	2.37	2.34	2.35	2.39	2.31
Bankfull Mean Depth (ft)	1.1	1.14	1.16	1.16	1.26
Bankfull Width (ft)	21.23	19.3	20.27	21.3	19.44

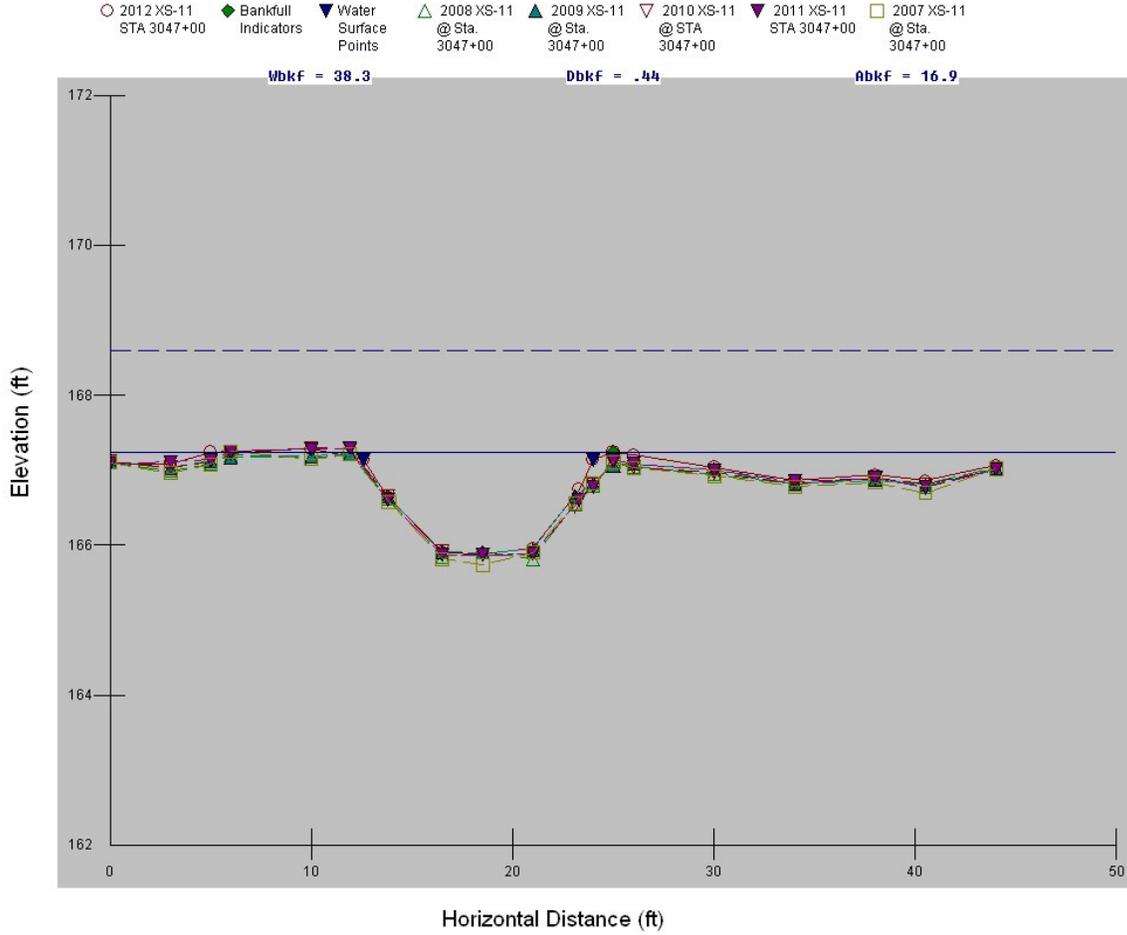
UT to Lumber River XS-11 @ STA 3047+00

Cross-Section #11 (Riffle) Abbreviated Morphological Summary					
	2008	2009	2010	2011	2012
Bankfull Width (ft)	12.76	12.57	12.56	12.69	14
Bankfull Mean Depth (ft)	0.86	0.76	0.83	0.87	0.82
Width/Depth Ratio	14.84	16.54	15.13	14.59	17.07
Bankfull Cross Sectional Area (ft²)	10.93	9.54	10.38	11.09	11.44
Maximum Bankfull Depth (ft)	1.3	1.16	1.23	1.27	1.35
Width of the Floodprone Area (ft)	44	44	44	44	44
Entrenchment Ratio	3.45	3.50	3.50	3.47	3.14

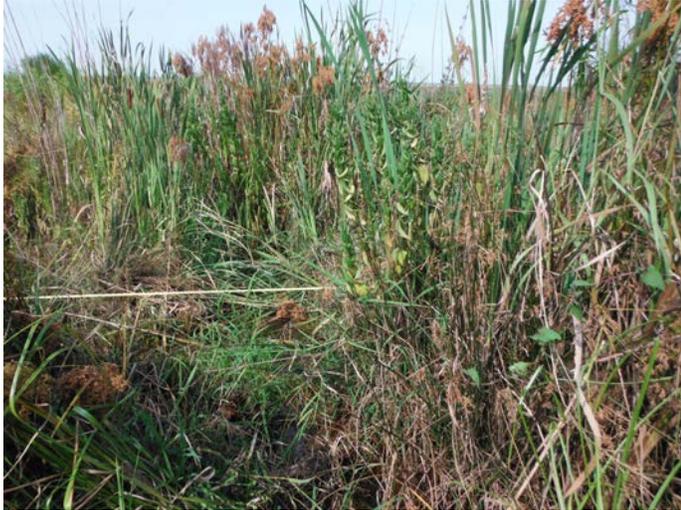
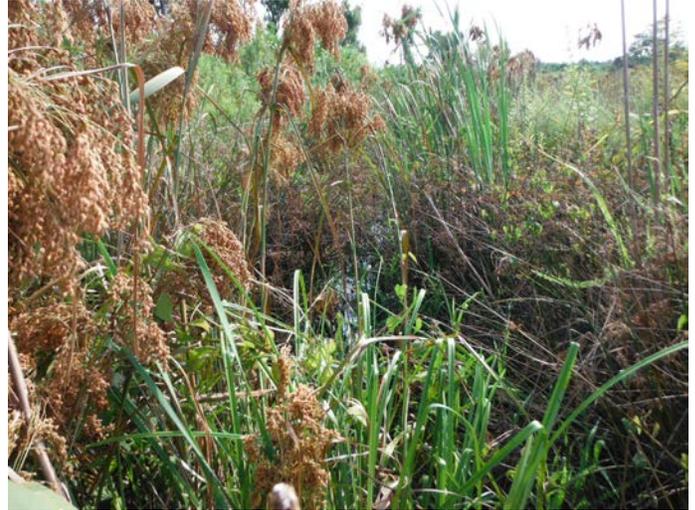
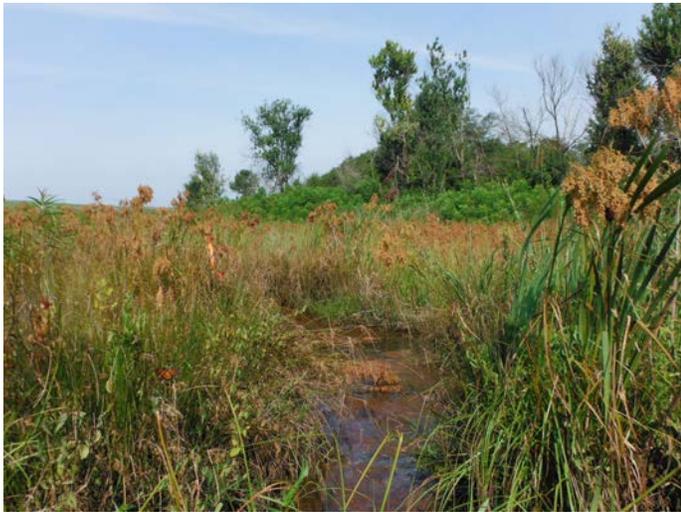
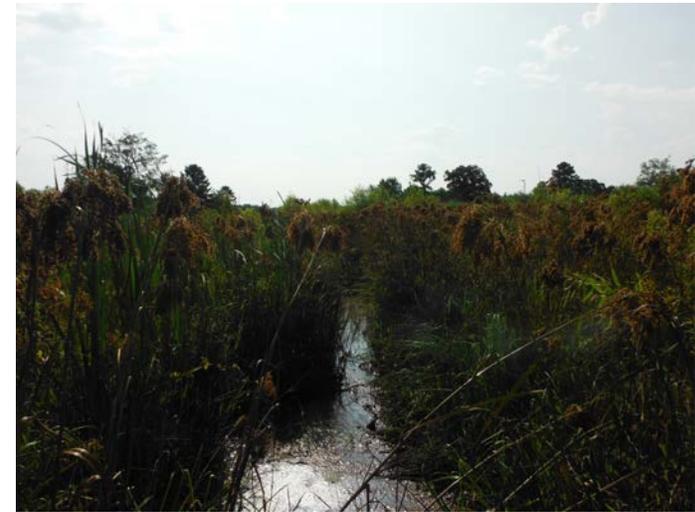
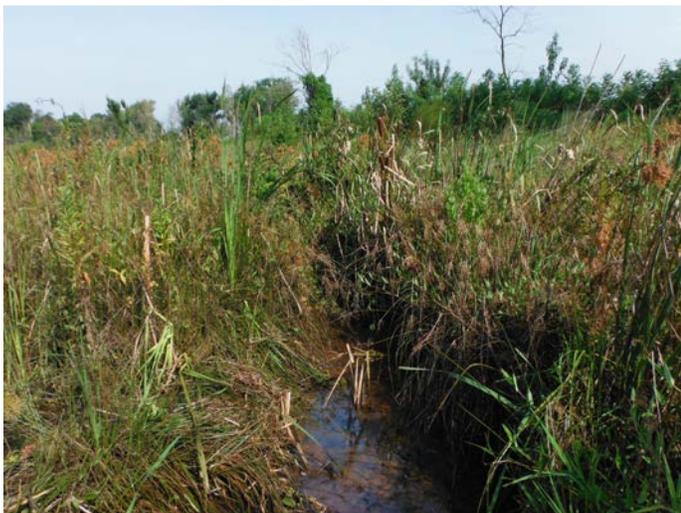
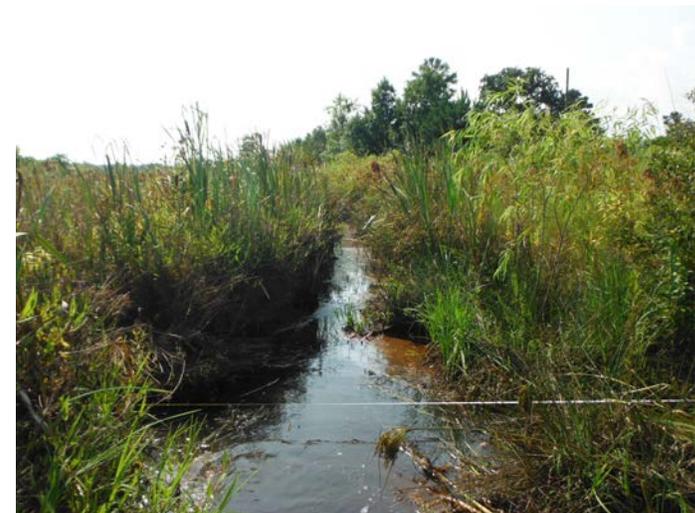
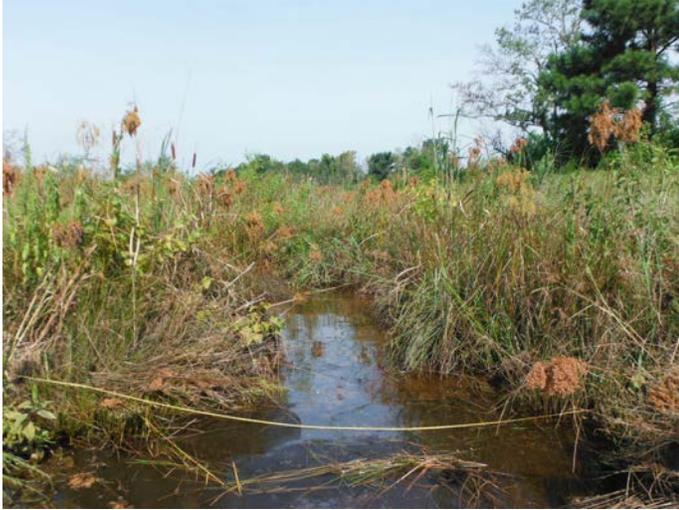
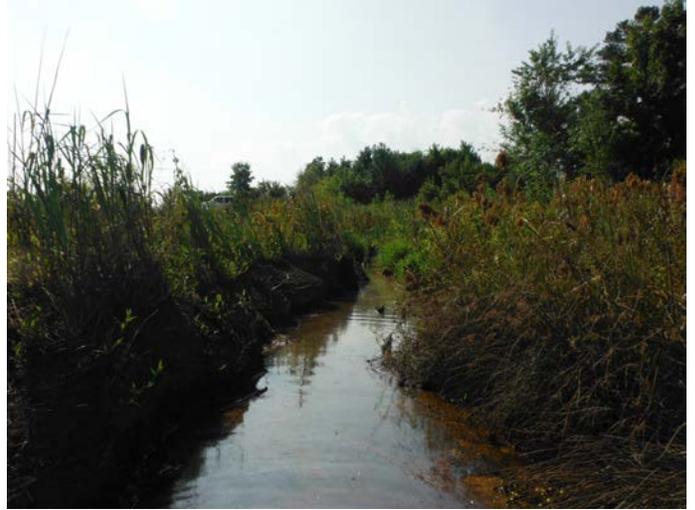
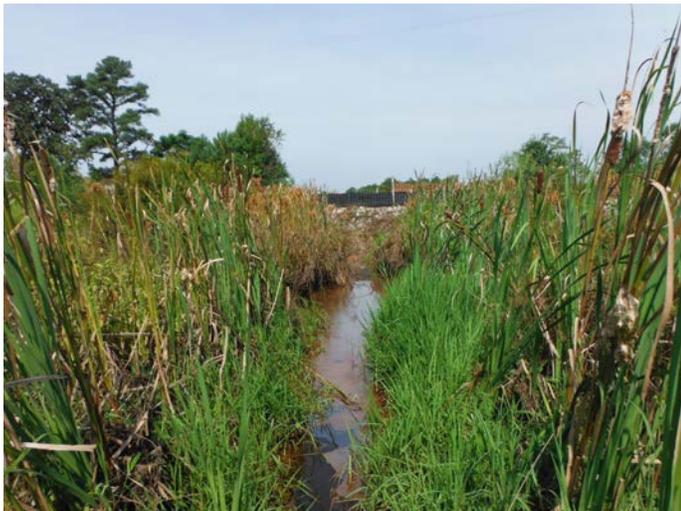
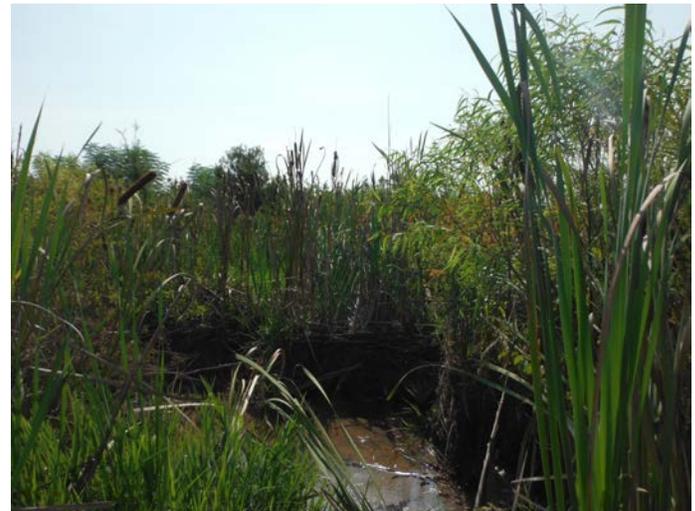
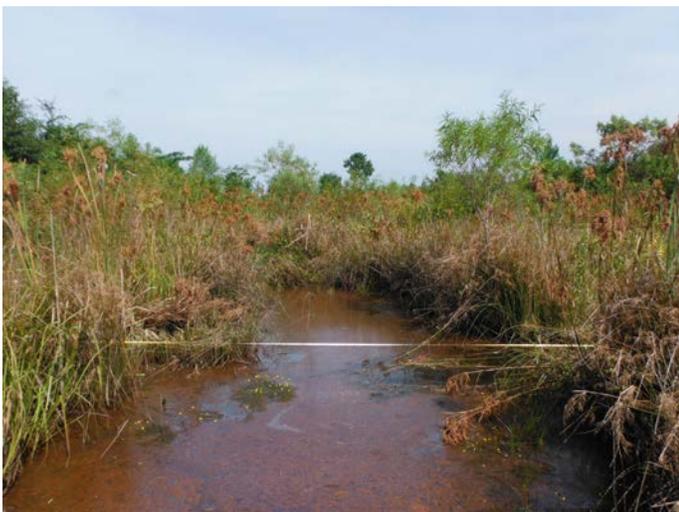
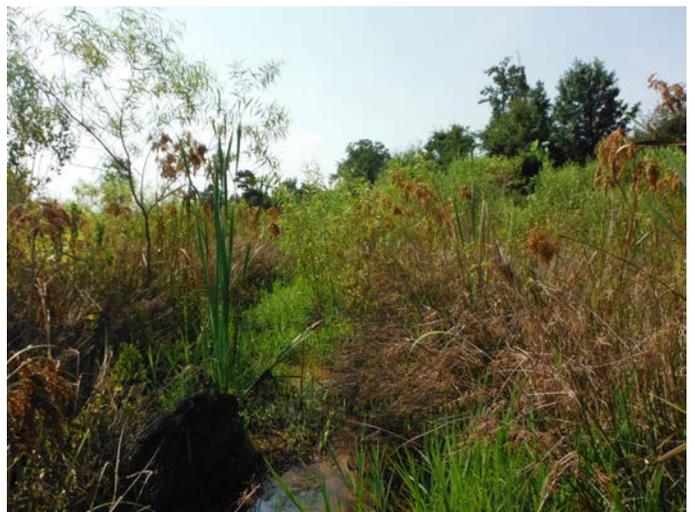
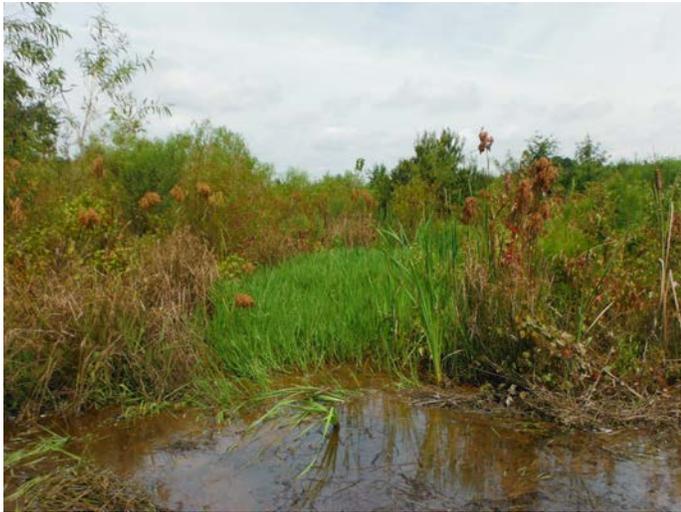
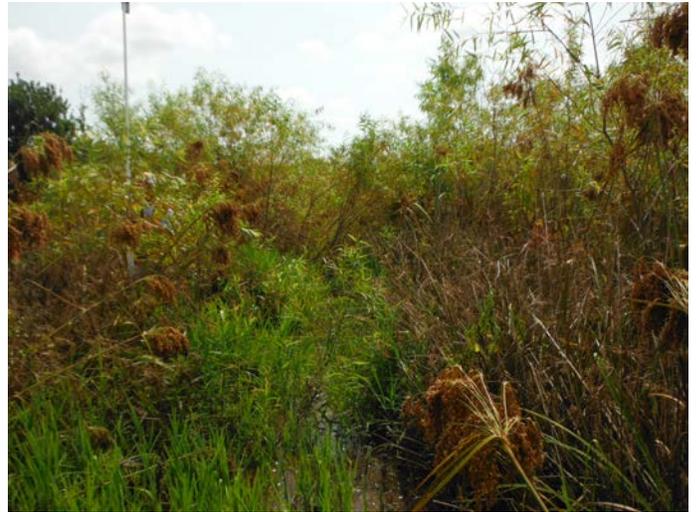
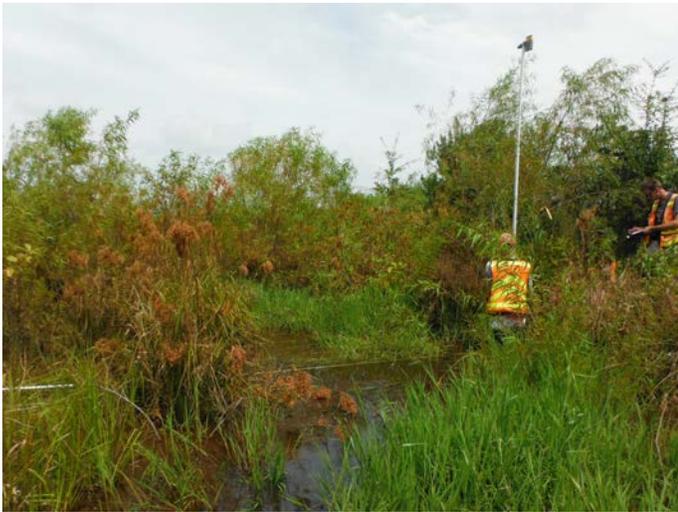
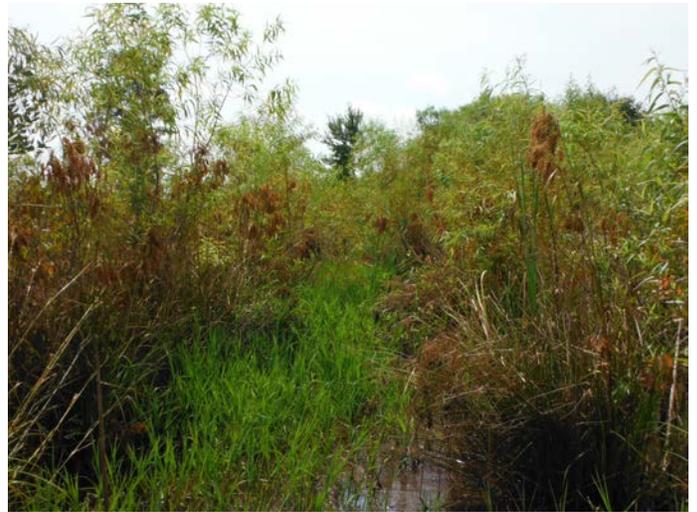
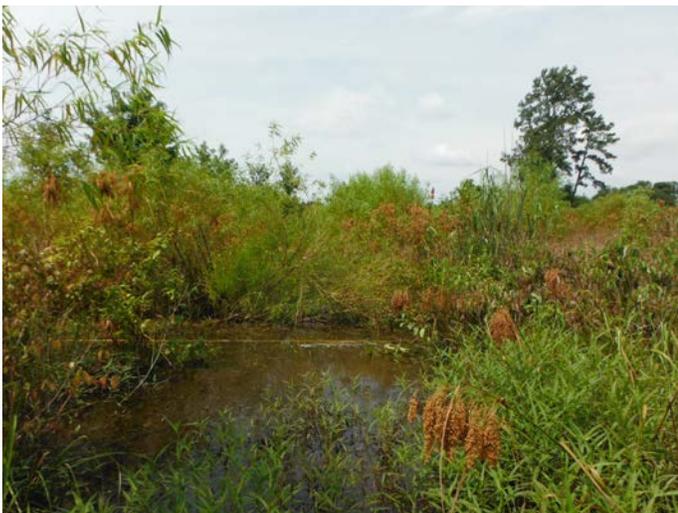
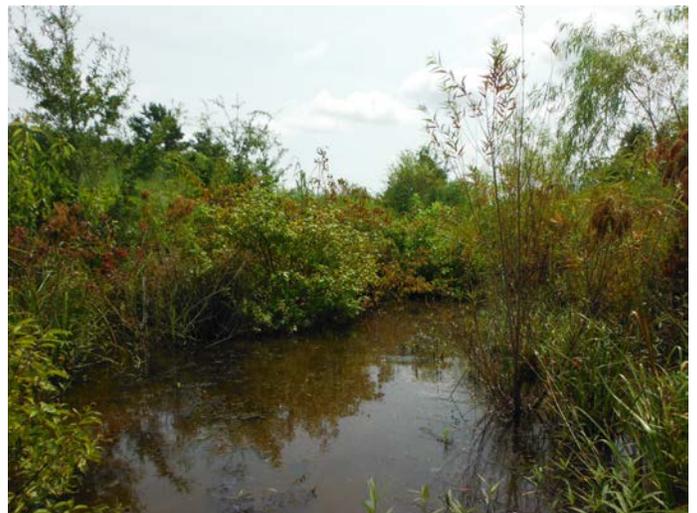
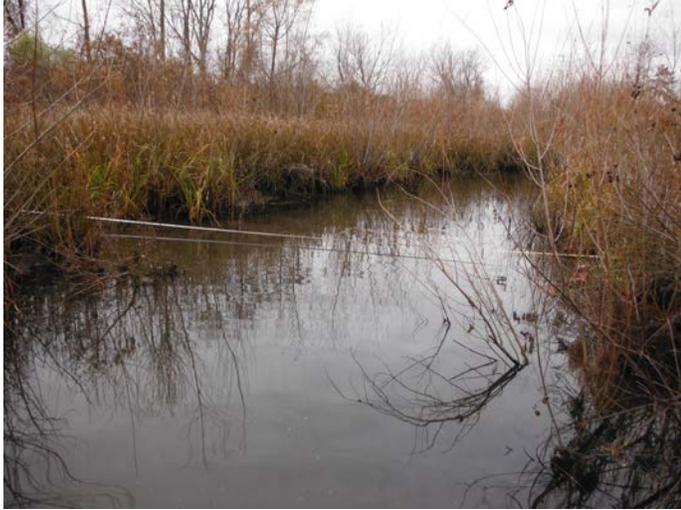
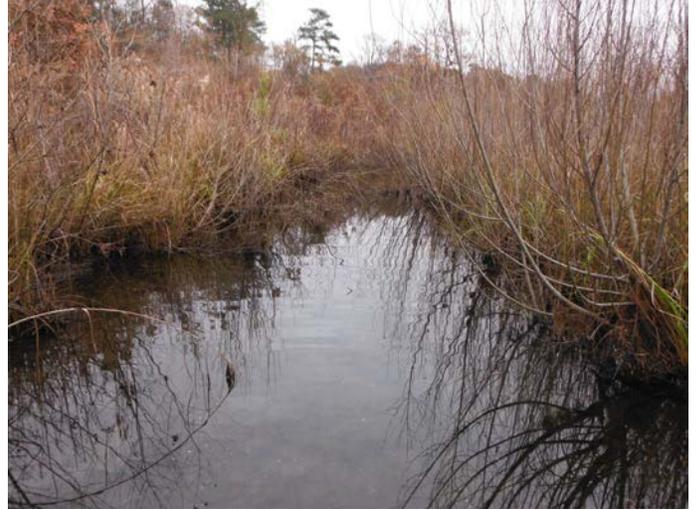
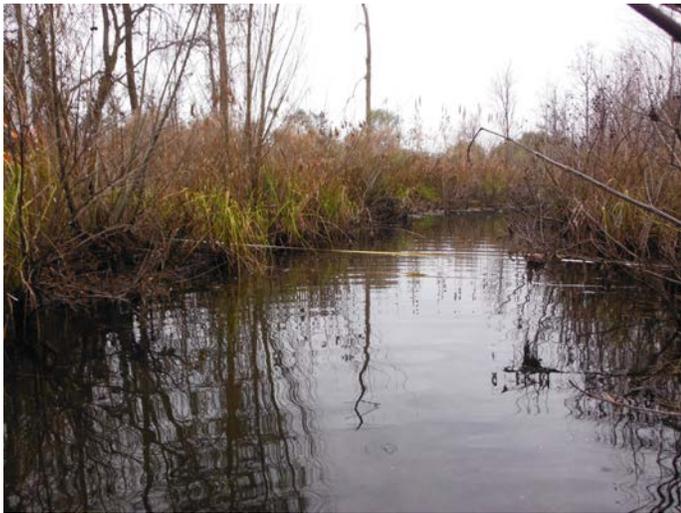
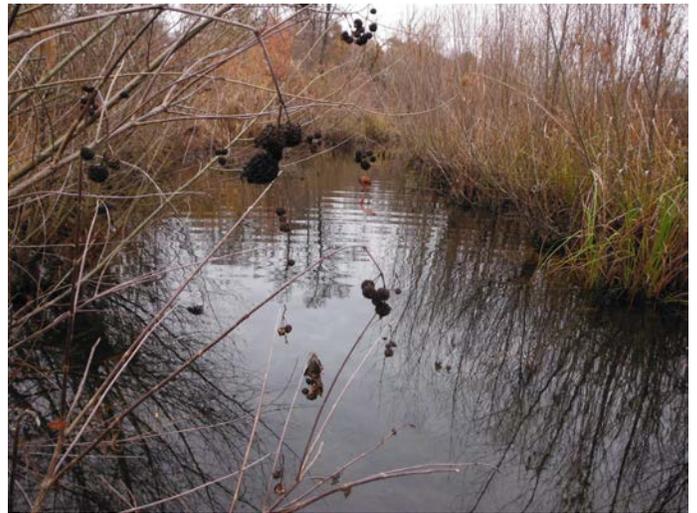
Photo points 1 through 11 showed an extensive growth of herbaceous and woody vegetation. The channel is stable throughout the stream restoration project at this time. A beaver dam was noted downstream of the stream restoration project in August 2012. USDA has been contacted to trap the beavers and remove the dam.
