# ANNUAL REPORT FOR 2012

**Holland Creek Site M Mitigation Site**  
**Madison County**  
**TIP No. R-2518A**  
**COE Action ID: SAW-2007-2197-357/300**  
**DWQ #: 20071134**

Prepared By:  
Natural Environment Section & Roadside Environmental Unit  
North Carolina Department of Transportation  
December 2012

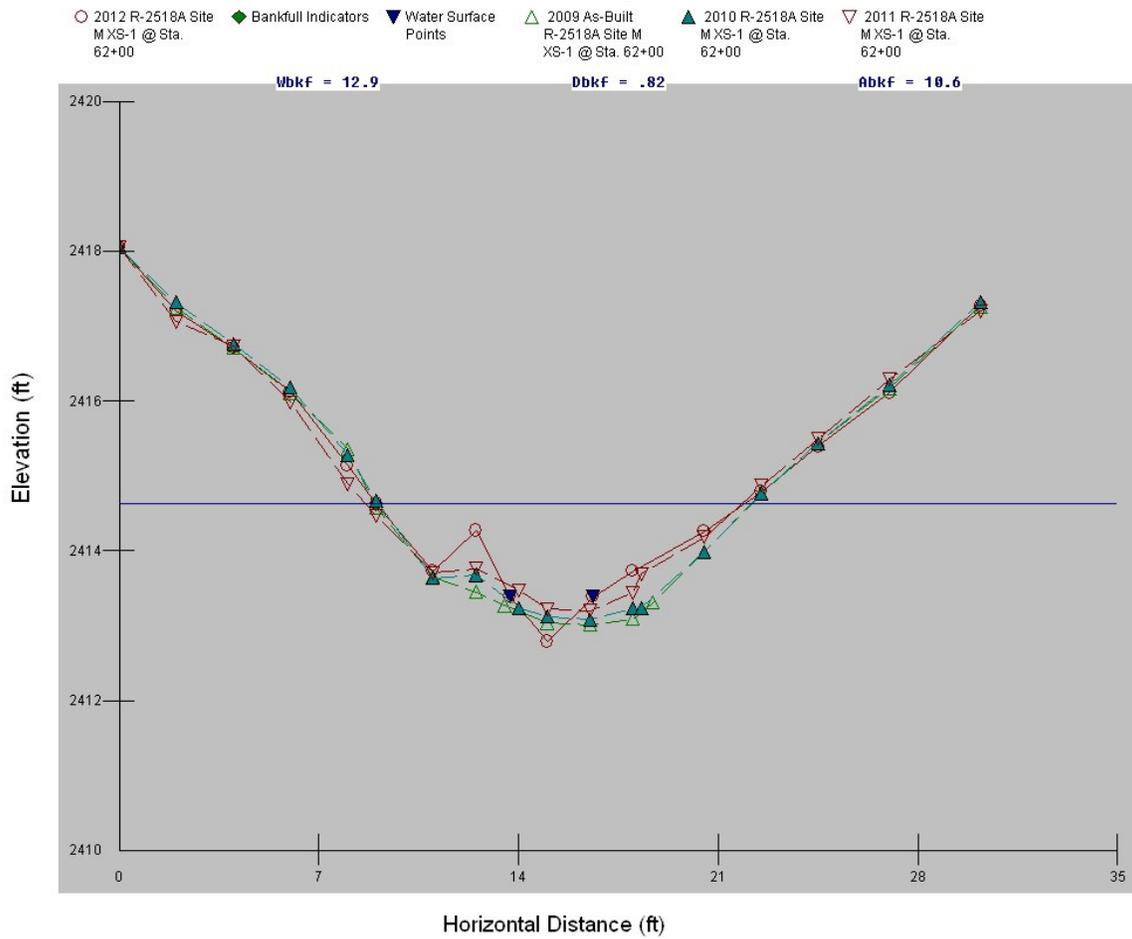
### R-2518A Site M XS-1 @ Sta. 62+00

Based on comparisons of the As-Built to the monitoring data, all of the cross sections appear stable with little or no active bank erosion. Graphs of the cross sections are presented in Appendix A. Future survey data will vary depending on actual location of rod placement and alignment; however, this information should remain similar in appearance. The longitudinal profile showed that the channel was stable for the 2012 monitoring evaluation. Pebble counts were not required per the permit conditions and therefore were not completed.

Site M: Cross-Section #1 (Riffle) Abbreviated Morphological Summary					
	2010	2011	2012	2013	2014
Bankfull Cross Sectional Area (ft <sup>2</sup> )	13.82	9.46	10.61		
Maximum Bankfull Depth (ft.)	1.59	1.27	1.84		
Width of the Floodprone Area (ft.)	21.42	18.84	23.17		
Bankfull Mean Depth (ft.)	1.04	0.77	0.82		
Width/Depth Ratio	12.73	16.03	15.73		
Entrenchment Ratio	1.62	1.53	1.8		
Bankfull Width (ft.)	13.24	12.34	12.9

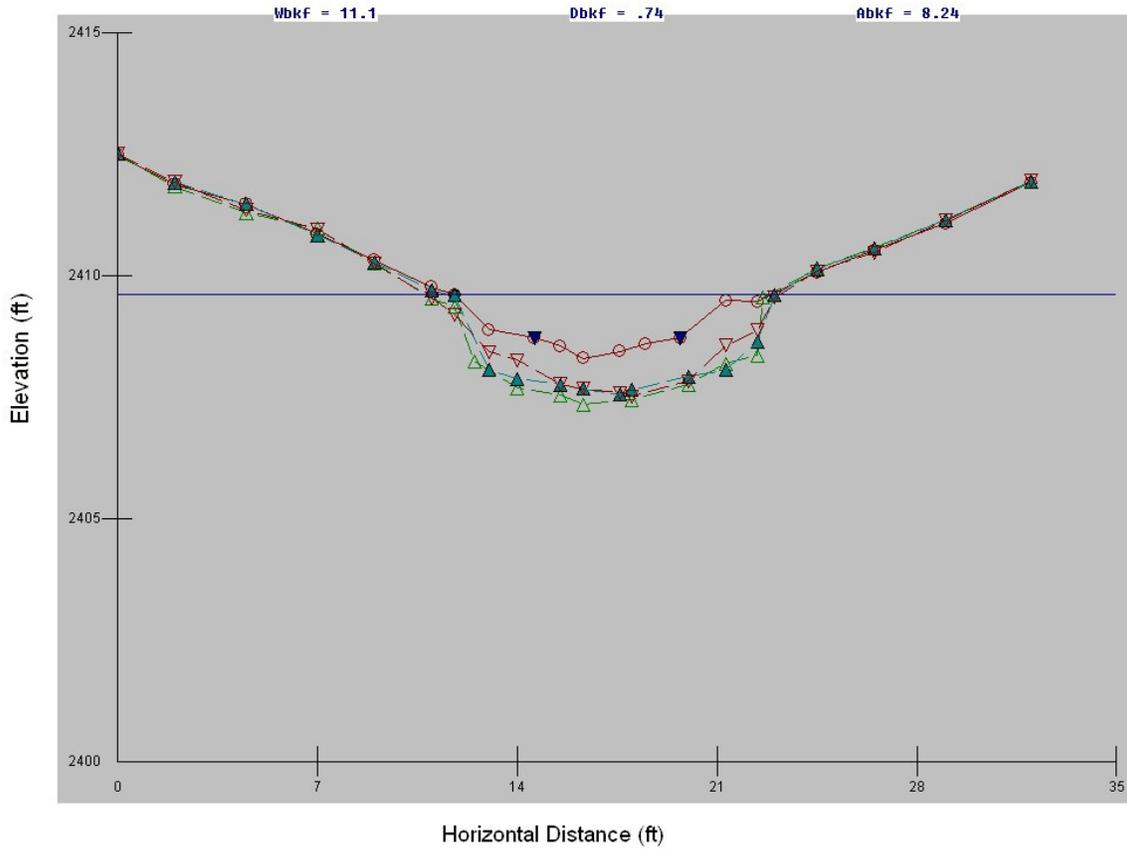
### R-2518A Site M XS-2 @ Sta. 198+50

Site M: Cross-Section #2 (Pool) Abbreviated Morphological Summary					
	2010	2011	2012	2013	2014
<b>Bankfull Cross Sectional Area (ft<sup>2</sup>)</b>	17.46	15.98	8.24		
<b>Maximum Bankfull Depth (ft.)</b>	2.04	2.03	1.31		
<b>Bankfull Mean Depth (ft.)</b>	1.56	1.33	0.74		
<b>Bankfull Width (ft.)</b>	11.2	12.06	11.09

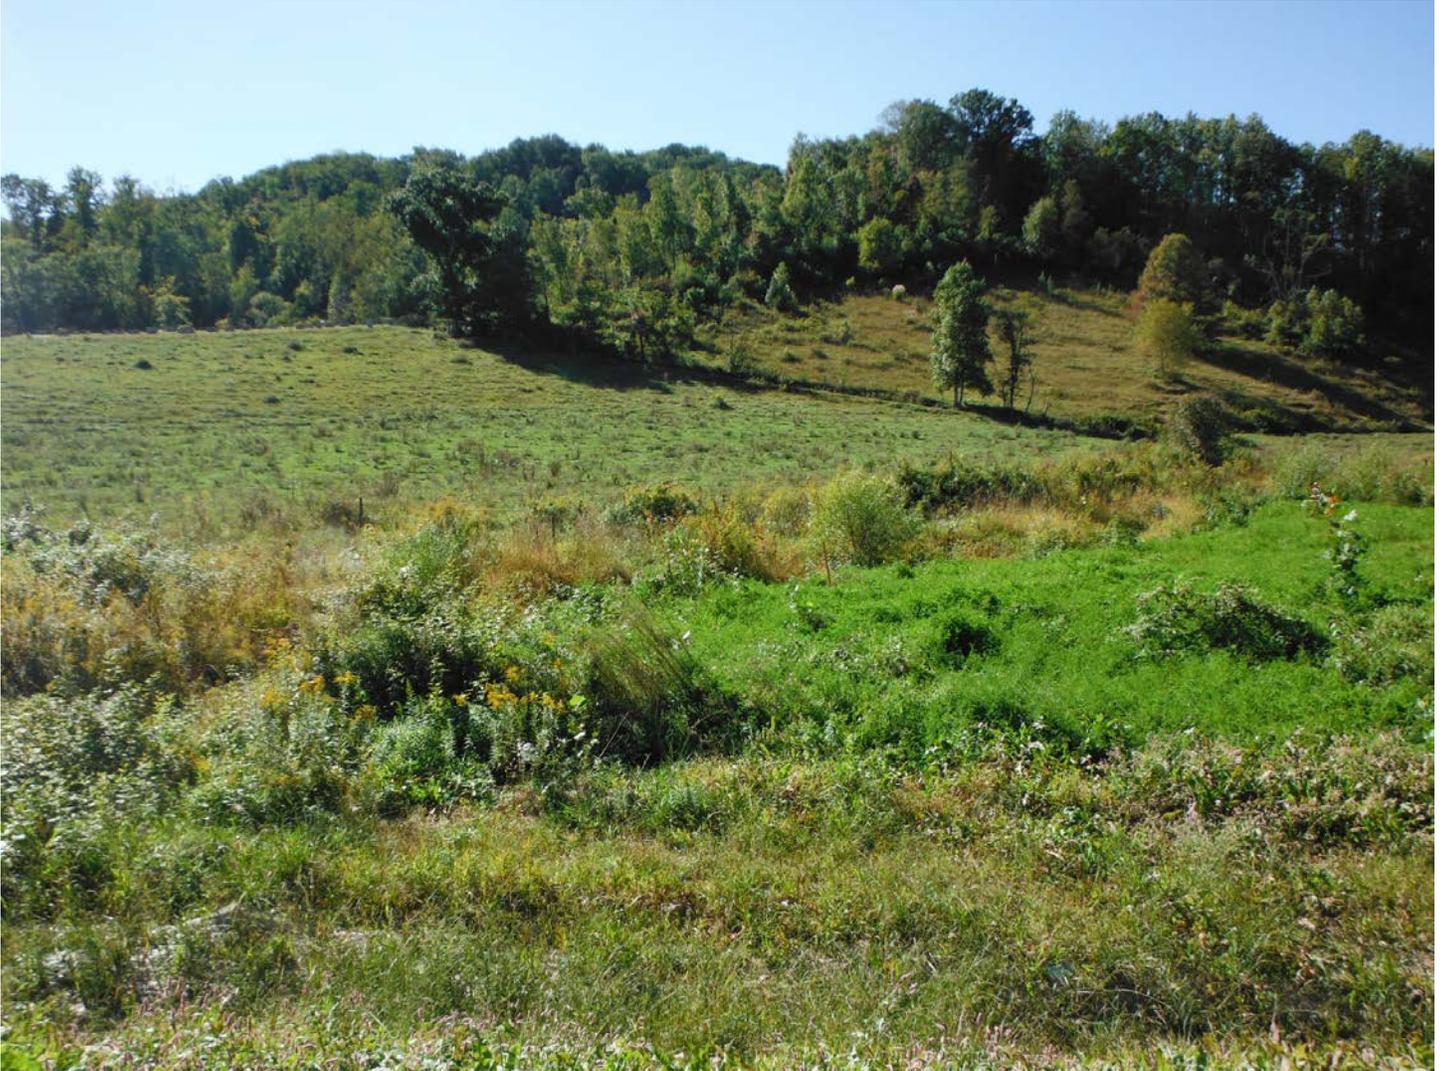
Vegetation Overview Photo

**Streambank & Buffer Vegetation:** The streambank reforestation was completed in March 2012. The Year 1 vegetation monitoring evaluation noted: Type I: Black Willow, Silky Dogwood and Type II: Sycamore, Green Ash, and Tulip Poplar were surviving with limited numbers at the time of monitoring evaluation.

NCDOT plans to complete a supplemental planting at the site by March 2013. NCDOT will continue to monitor the planted vegetation in 2013.
