ANNUAL REPORT FOR 2012

**Middle Fork Creek Site E Mitigation Site
Madison County
TIP No. R-2518A
COE Action ID: SAW-2007-2197-357/300
DWQ #: 20071134**

Prepared By:
Natural Environment Section & Roadside Environmental Unit
North Carolina Department of Transportation
December 2012

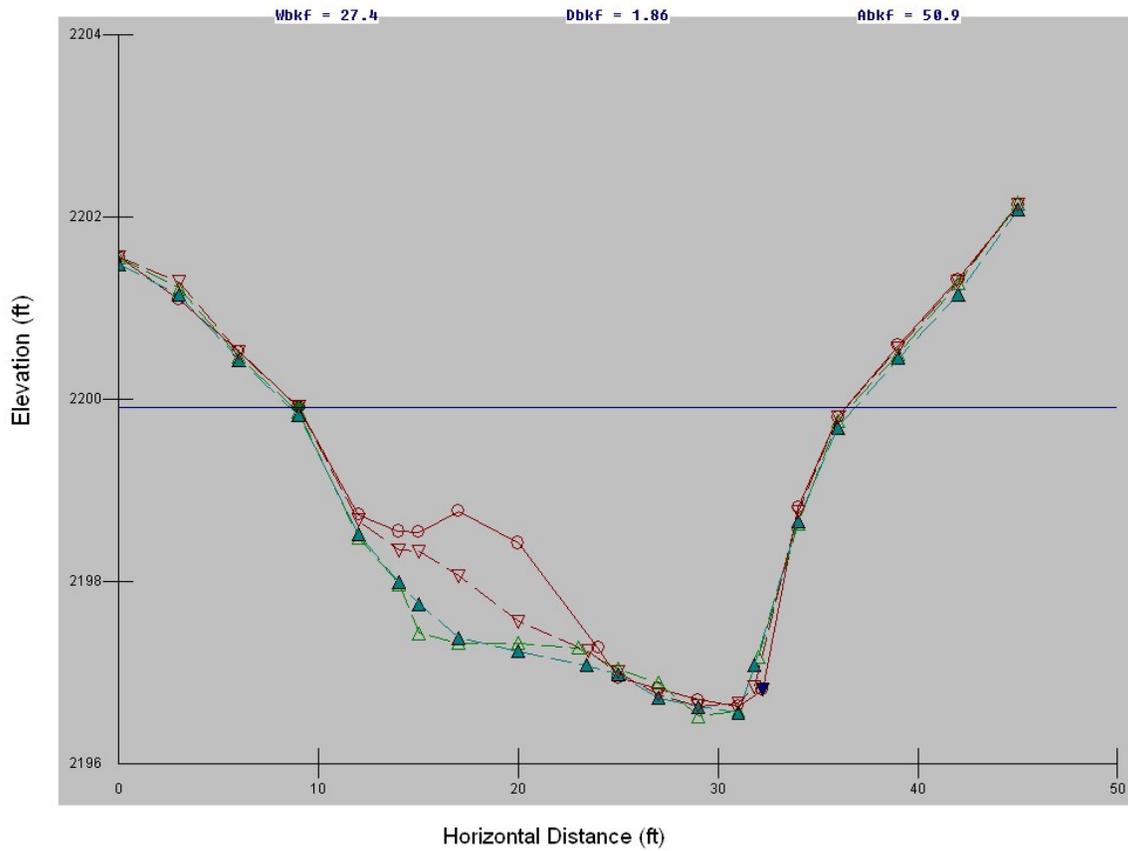
R-2518A Site E XS-1 @ 102+00

Based on comparisons of the As-Built to the monitoring data, all of the cross sections appear stable with little or no active bank erosion. Graphs of the cross sections are presented in Appendix A. Future survey data will vary depending on actual location of rod placement and alignment; however, this information should remain similar in appearance. The longitudinal profile showed that the channel bed was stable for the 2012 monitoring evaluation. Areas of bank erosion were noted downstream of PP#2 and upstream of PP#4 on the left bank. NCDOT plans to live stake the eroded banks by March 2013 to help stabilize these areas. Pebble counts were not required per the permit conditions and therefore were not completed.

Site E: Cross-Section #1 (Riffle) Abbreviated Morphological Summary					
	2010	2011	2012	2013	2014
Bankfull Cross Sectional Area (ft ²)	59.32	56.44	50.89		
Maximum Bankfull Depth (ft.)	3.26	3.28	3.28		
Width of the Floodprone Area (ft.)	45	45	45		
Bankfull Mean Depth (ft.)	2.16	2.06	1.86		
Width/Depth Ratio	12.74	13.32	14.74		
Entrenchment Ratio	1.64	1.64	1.64		
Bankfull Width (ft.)	27.51	27.43	27.42

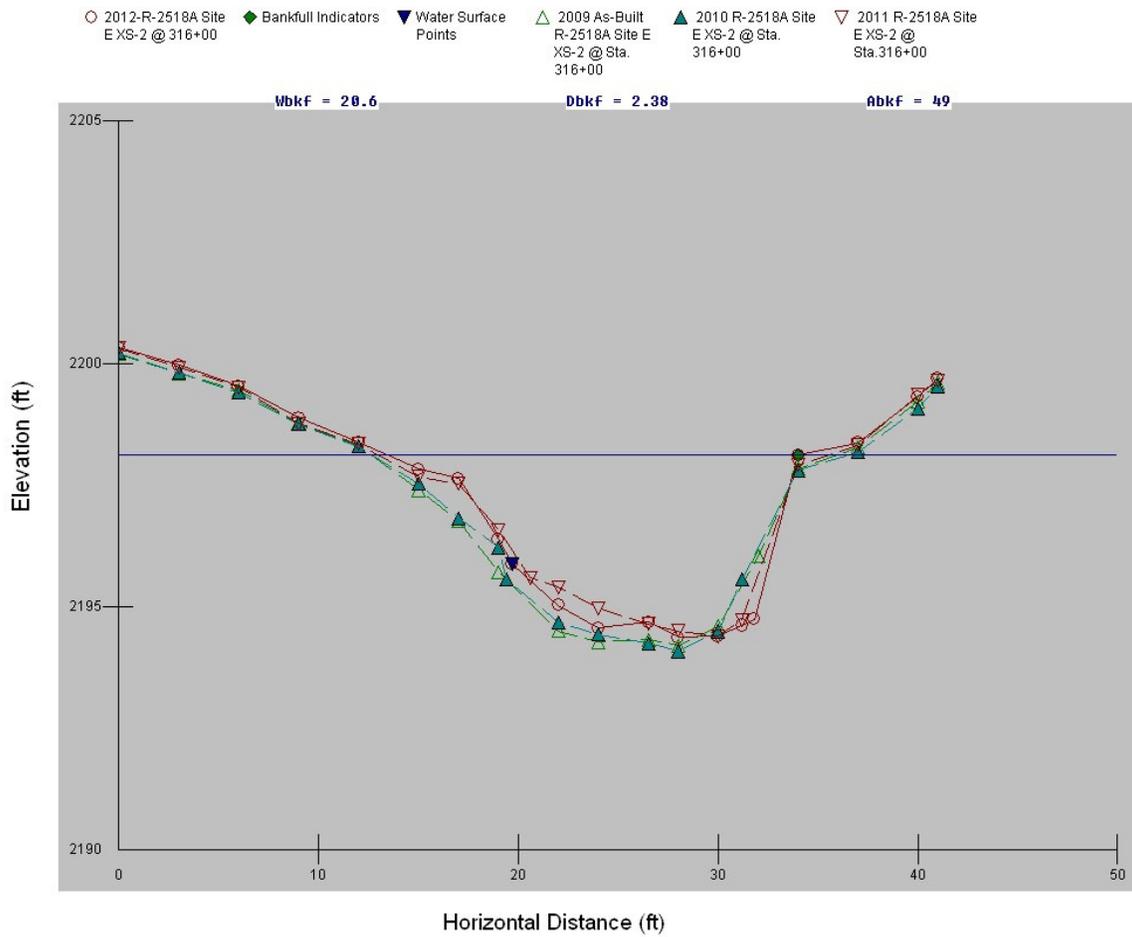
R-2518A Site E XS-2 @ 316+00

Site E: Cross-Section #2 (Pool) Abbreviated Morphological Summary					
	2010	2011	2012	2013	2014
Bankfull Cross Sectional Area (ft²)	45.83	42.38	49.01		
Maximum Bankfull Depth (ft.)	3.72	3.52	3.74		
Bankfull Mean Depth (ft.)	2.28	2.11	2.38		
Bankfull Width (ft.)	20.07	20.07	20.55

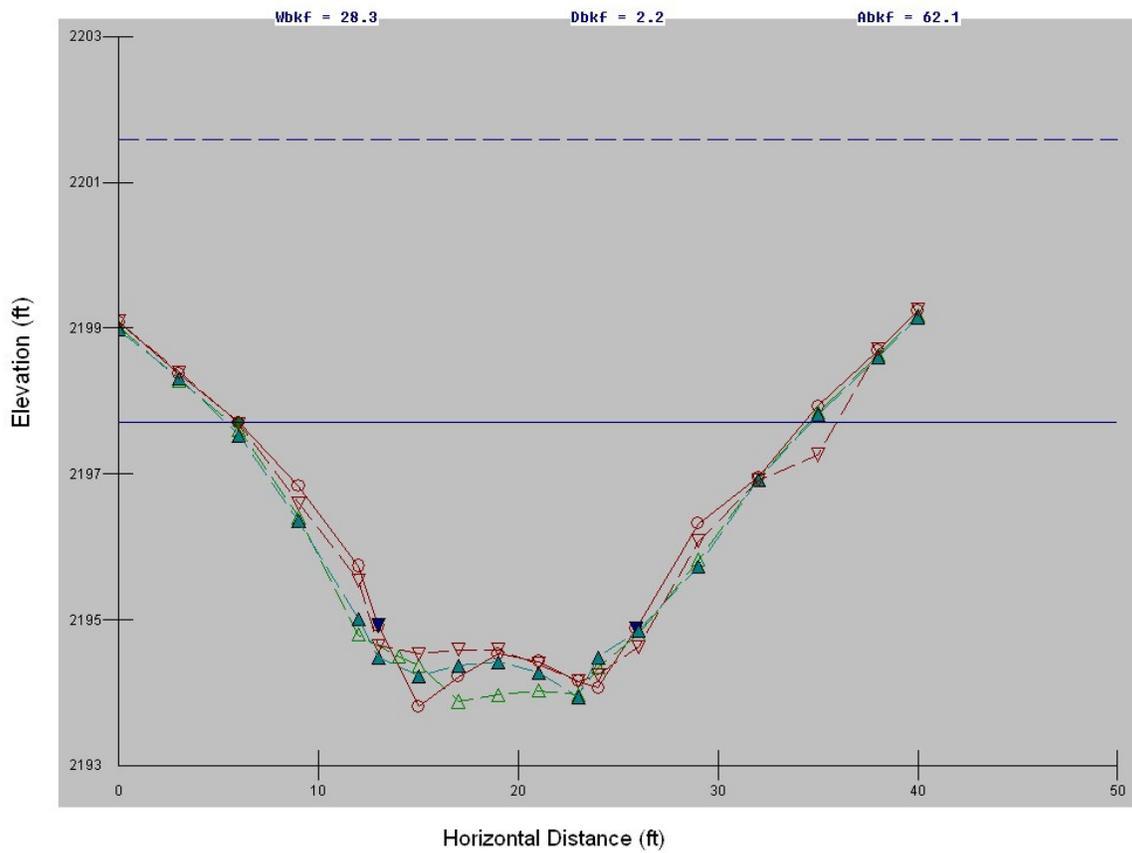
R-2518A Site E XS-3 @ STA 500+00

Site E: Cross-Section #3 (Riffle) Abbreviated Morphological Summary					
	2010	2011	2012	2013	2014
Bankfull Cross Sectional Area (ft ²)	62.4	63.57	62.14		
Maximum Bankfull Depth (ft.)	3.59	3.53	3.89		
Width of the Floodprone Area (ft.)	40	40	40		
Bankfull Mean Depth (ft.)	2.22	2.13	2.2		
Width/Depth Ratio	12.64	14.03	12.86		
Entrenchment Ratio	1.43	1.34	1.41		
Bankfull Width (ft.)	28.06	29.89	28.3

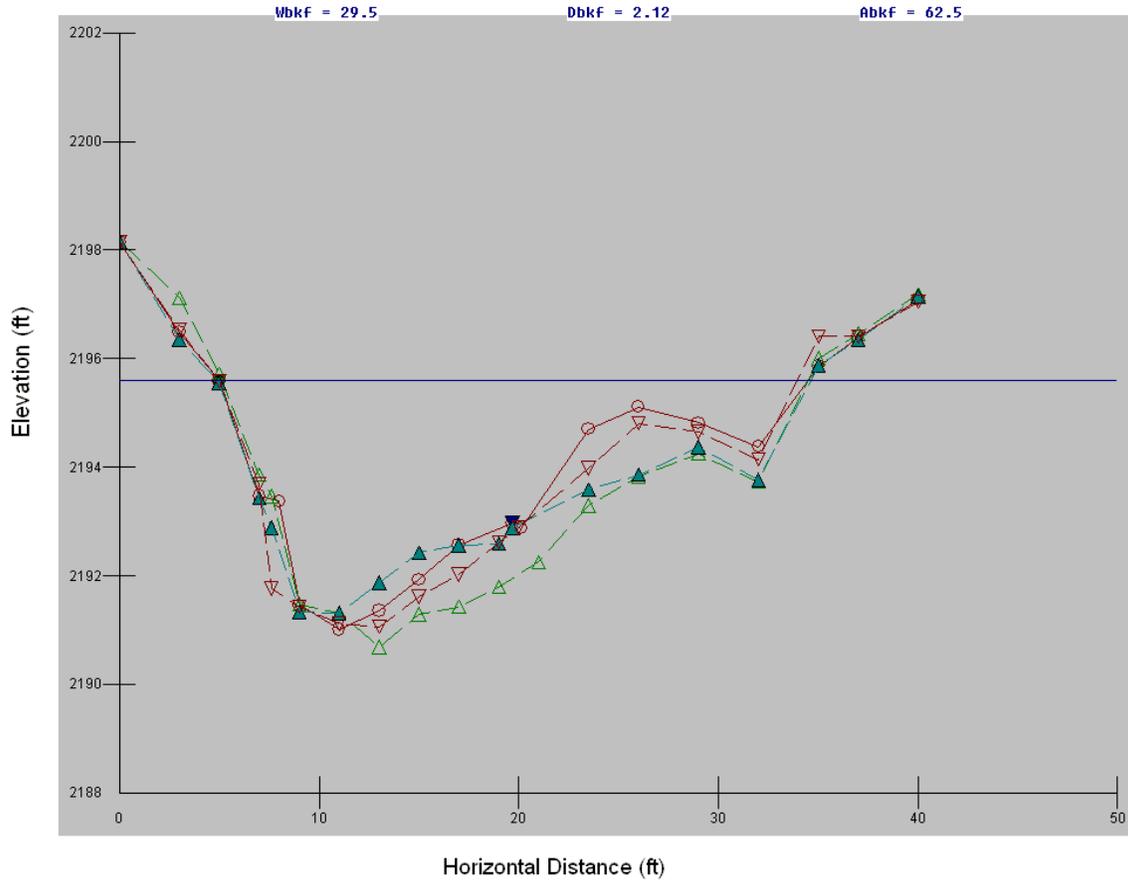
R-2518A Site E XS-4 @ STA 805+00

Site E: Cross-Section #4 (Pool) Abbreviated Morphological Summary					
	2010	2011	2012	2013	2014
Bankfull Cross Sectional Area (ft²)	69.95	70.4	62.52		
Maximum Bankfull Depth (ft.)	4.24	4.53	4.58		
Bankfull Mean Depth (ft.)	2.37	2.43	2.12		
Bankfull Width (ft.)	29.53	28.92	29.45

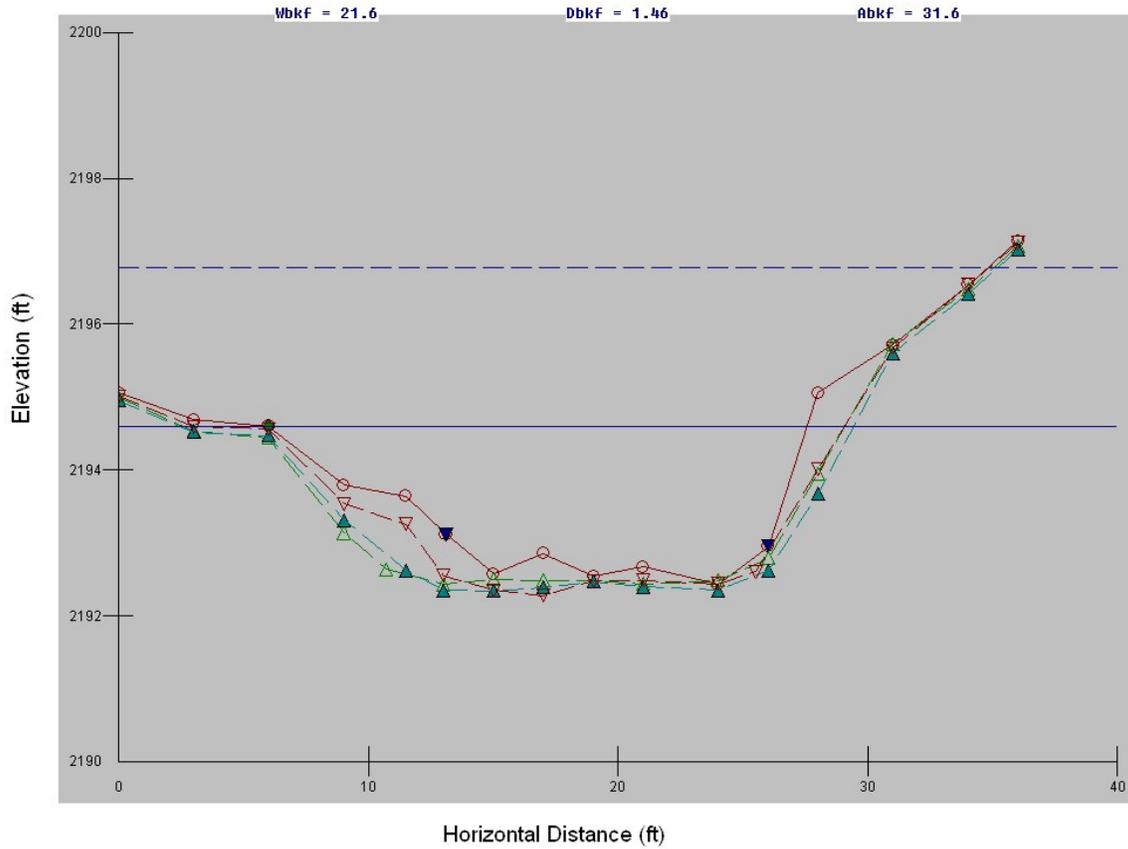
R-2518A Site E XS-5 @ STA 853+00

Site E: Cross-Section #5 (Riffle) Abbreviated Morphological Summary					
	2010	2011	2012	2013	2014
Bankfull Cross Sectional Area (ft ²)	38.49	36.94	31.55		
Maximum Bankfull Depth (ft.)	2.13	2.28	2.17		
Width of the Floodprone Area (ft.)	34.6	35.05	34.77		
Bankfull Mean Depth (ft.)	1.66	1.61	1.46		
Width/Depth Ratio	14	14.28	14.77		
Entrenchment Ratio	1.49	1.52	1.61		
Bankfull Width (ft.)	23.24	22.99	21.56

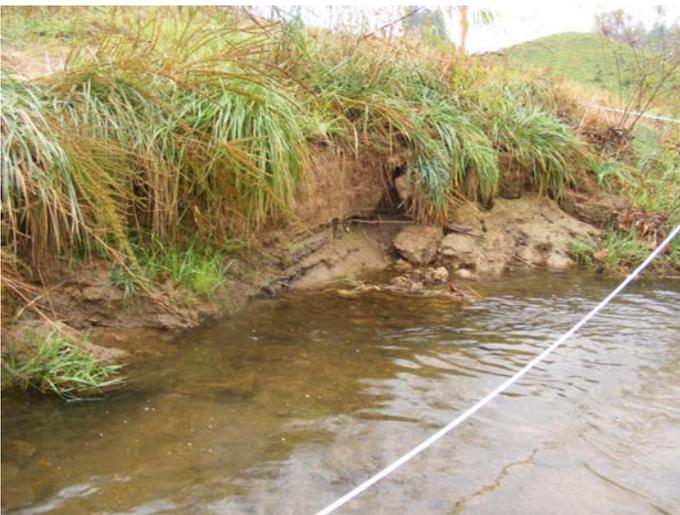
Based on the overall conclusions of monitoring at the Middle Fork Creek Site E, it has met the required monitoring protocols for the third formal year of monitoring on the stream and first formal year of monitoring on the planted vegetation. The channel throughout the stream restoration site is stable, except for, some areas of bank erosion that were noted downstream of PP#2 and upstream of PP#4 on the left bank. NCDOT plans to plant live stakes on the eroded banks by March 2013. The streambank and buffer area were planted in March 2012 with live stakes and bareroot seedlings. The planted vegetation is surviving at this time. NCDOT will continue stream monitoring at the Middle Fork Creek Site E Mitigation Site in 2013.

Bank erosion on left bank downstream of PP#2

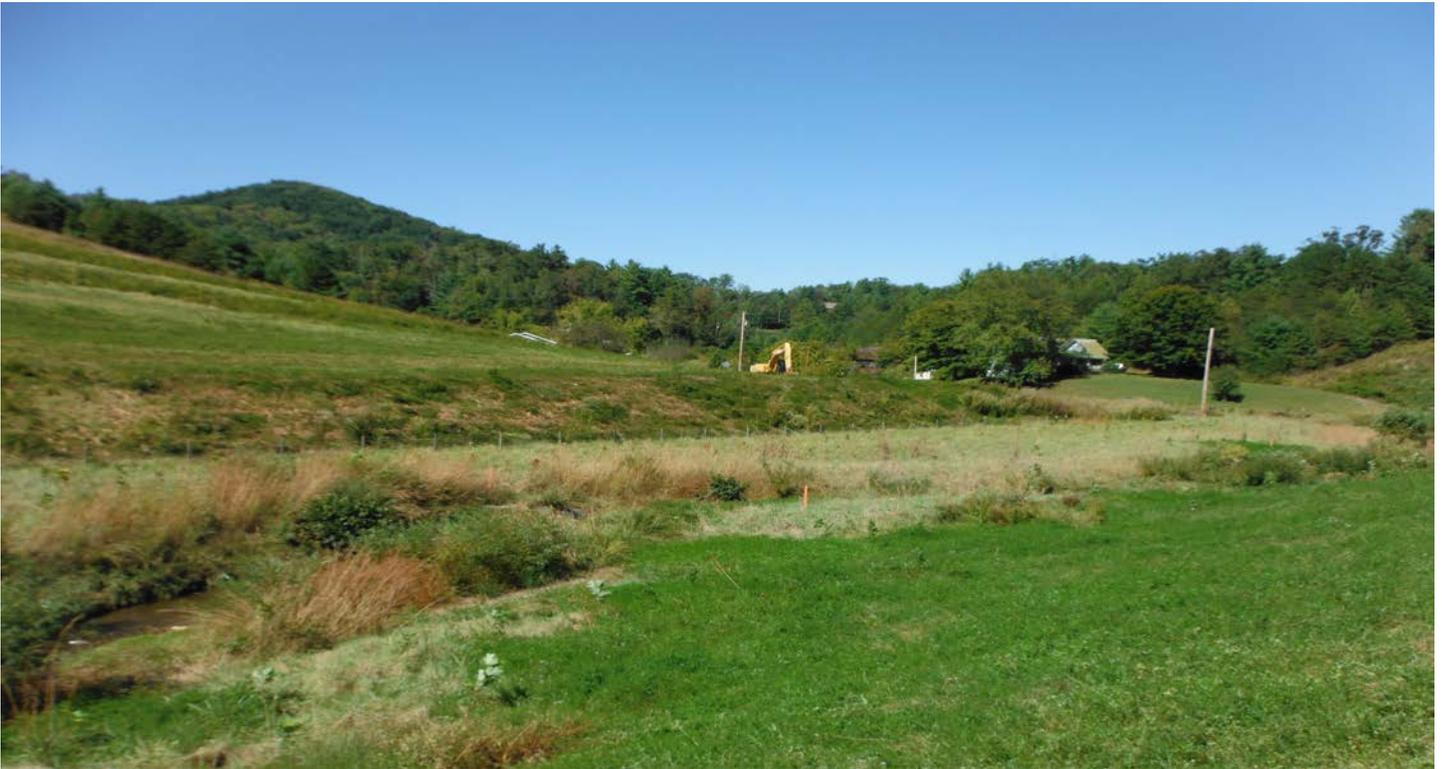
Streambank & Buffer Vegetation: The streambank reforestation was completed in March 2012. The Year 1 vegetation monitoring evaluation noted: Type I: Black Willow, Silky Dogwood, and Type II: Sycamore, Green Ash, Tulip Poplar and White Oak were surviving at the time of the monitoring evaluation.

Vegetation Overview Photo (Looking Upstream)

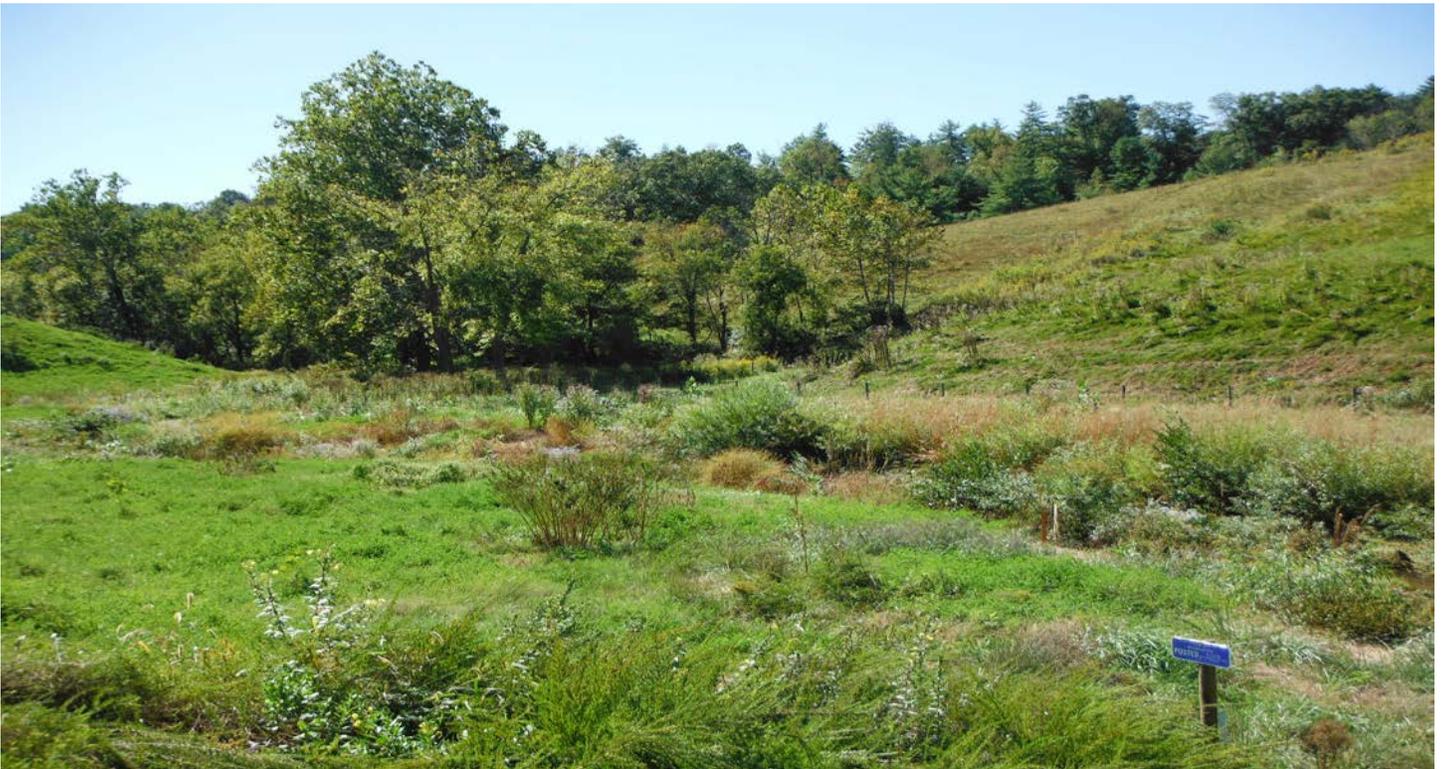
Vegetation Overview Photo (Looking Downstream)

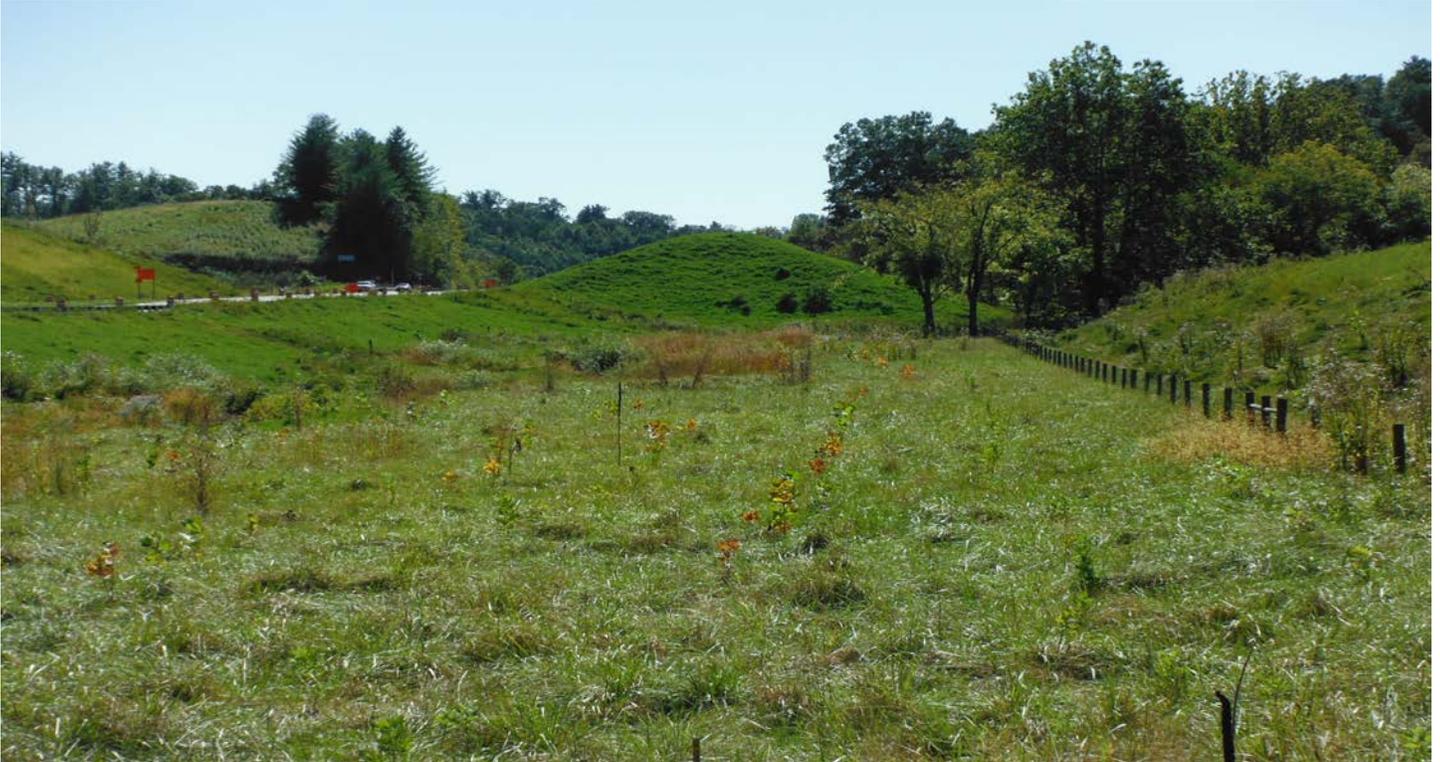
Vegetation Overview Photo (Right Buffer)
