ANNUAL REPORT FOR 2011

**UT to Adams Creek Mitigation Site
Cabarrus County
TIP No. R-2533B (Site 24)**

Prepared By:
Natural Environment Unit & Roadside Environmental Unit
North Carolina Department of Transportation
September 2011

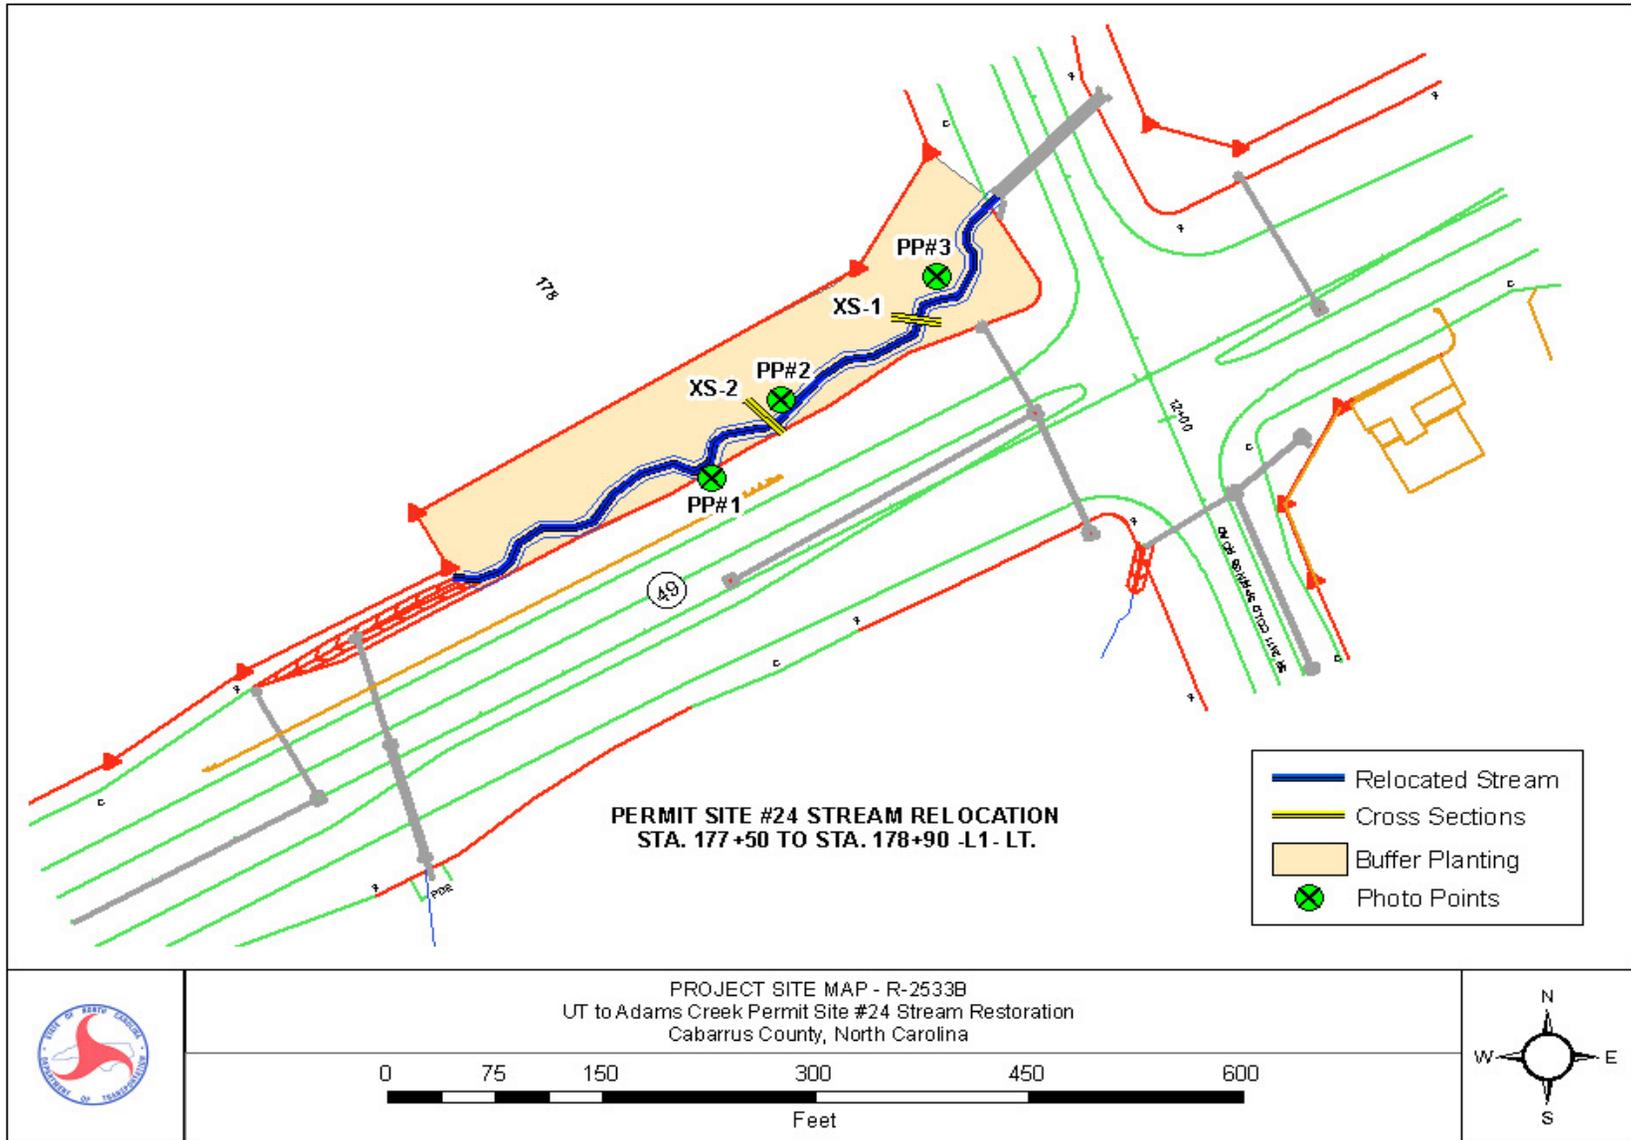
Figure 2. UT to Adams Creek Site #24 Map

The following report summarizes the stream monitoring activities that have occurred during the Year 2011 at the UT to Adams Creek Stream Mitigation Site. Site # 24 is located on NC 49 in Cabarrus County at Sta. 177+50 to Sta. 178+90 –L1- LT. (Figure 1). The UT to Adams Creek Site was constructed to provide mitigation for stream impacts associated with Transportation Improvement Program (TIP) number R-2533B in Cabarrus County.

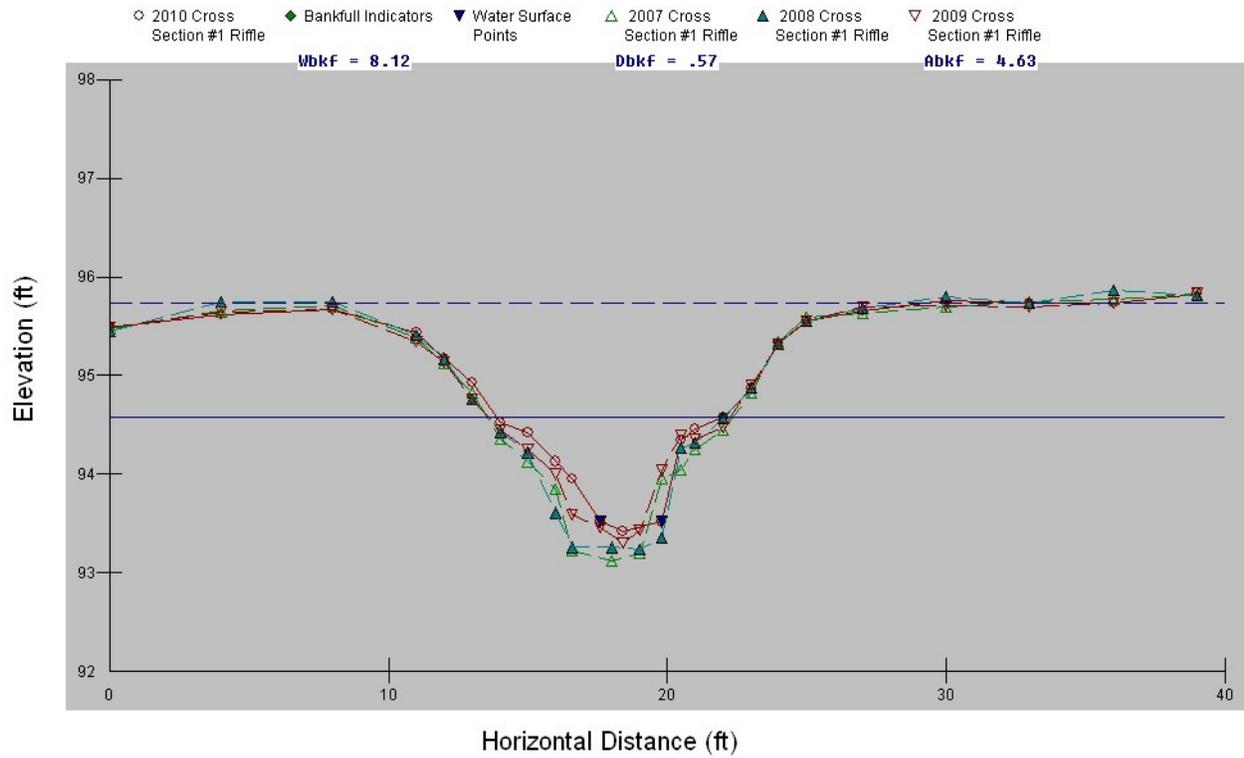
R-2533B Site #24 XS-1 Riffle

Based on comparisons of all four years of monitoring data, all of the cross sections appear stable with little or no active bank erosion. Graphs of the cross sections are presented in Appendix A. Future survey data will vary depending on actual location of rod placement and alignment; however, this information should remain similar in appearance. Pebble counts were not required per the permit conditions and therefore were not completed.

Site #24: Cross-Section #1 (Riffle) Abbreviated Morphological Summary				
	2007	2008	2009	2010
Bankfull Cross Sectional Area (ft ²)	5.5	6.5	4.22	4.63
Maximum Bankfull Depth (ft)	1.3	1.3	1.17	1.16
Width of the Floodprone Area (ft)	36.6	39	22	33.7
Bankfull Mean Depth (ft)	0.7	0.8	0.52	0.57
Width/Depth Ratio	12.1	10.9	15.5	14.25
Entrenchment Ratio	4.5	4.7	2.72	4.15
Bankfull Width (ft)	8.2	8.4	8.06	8.12

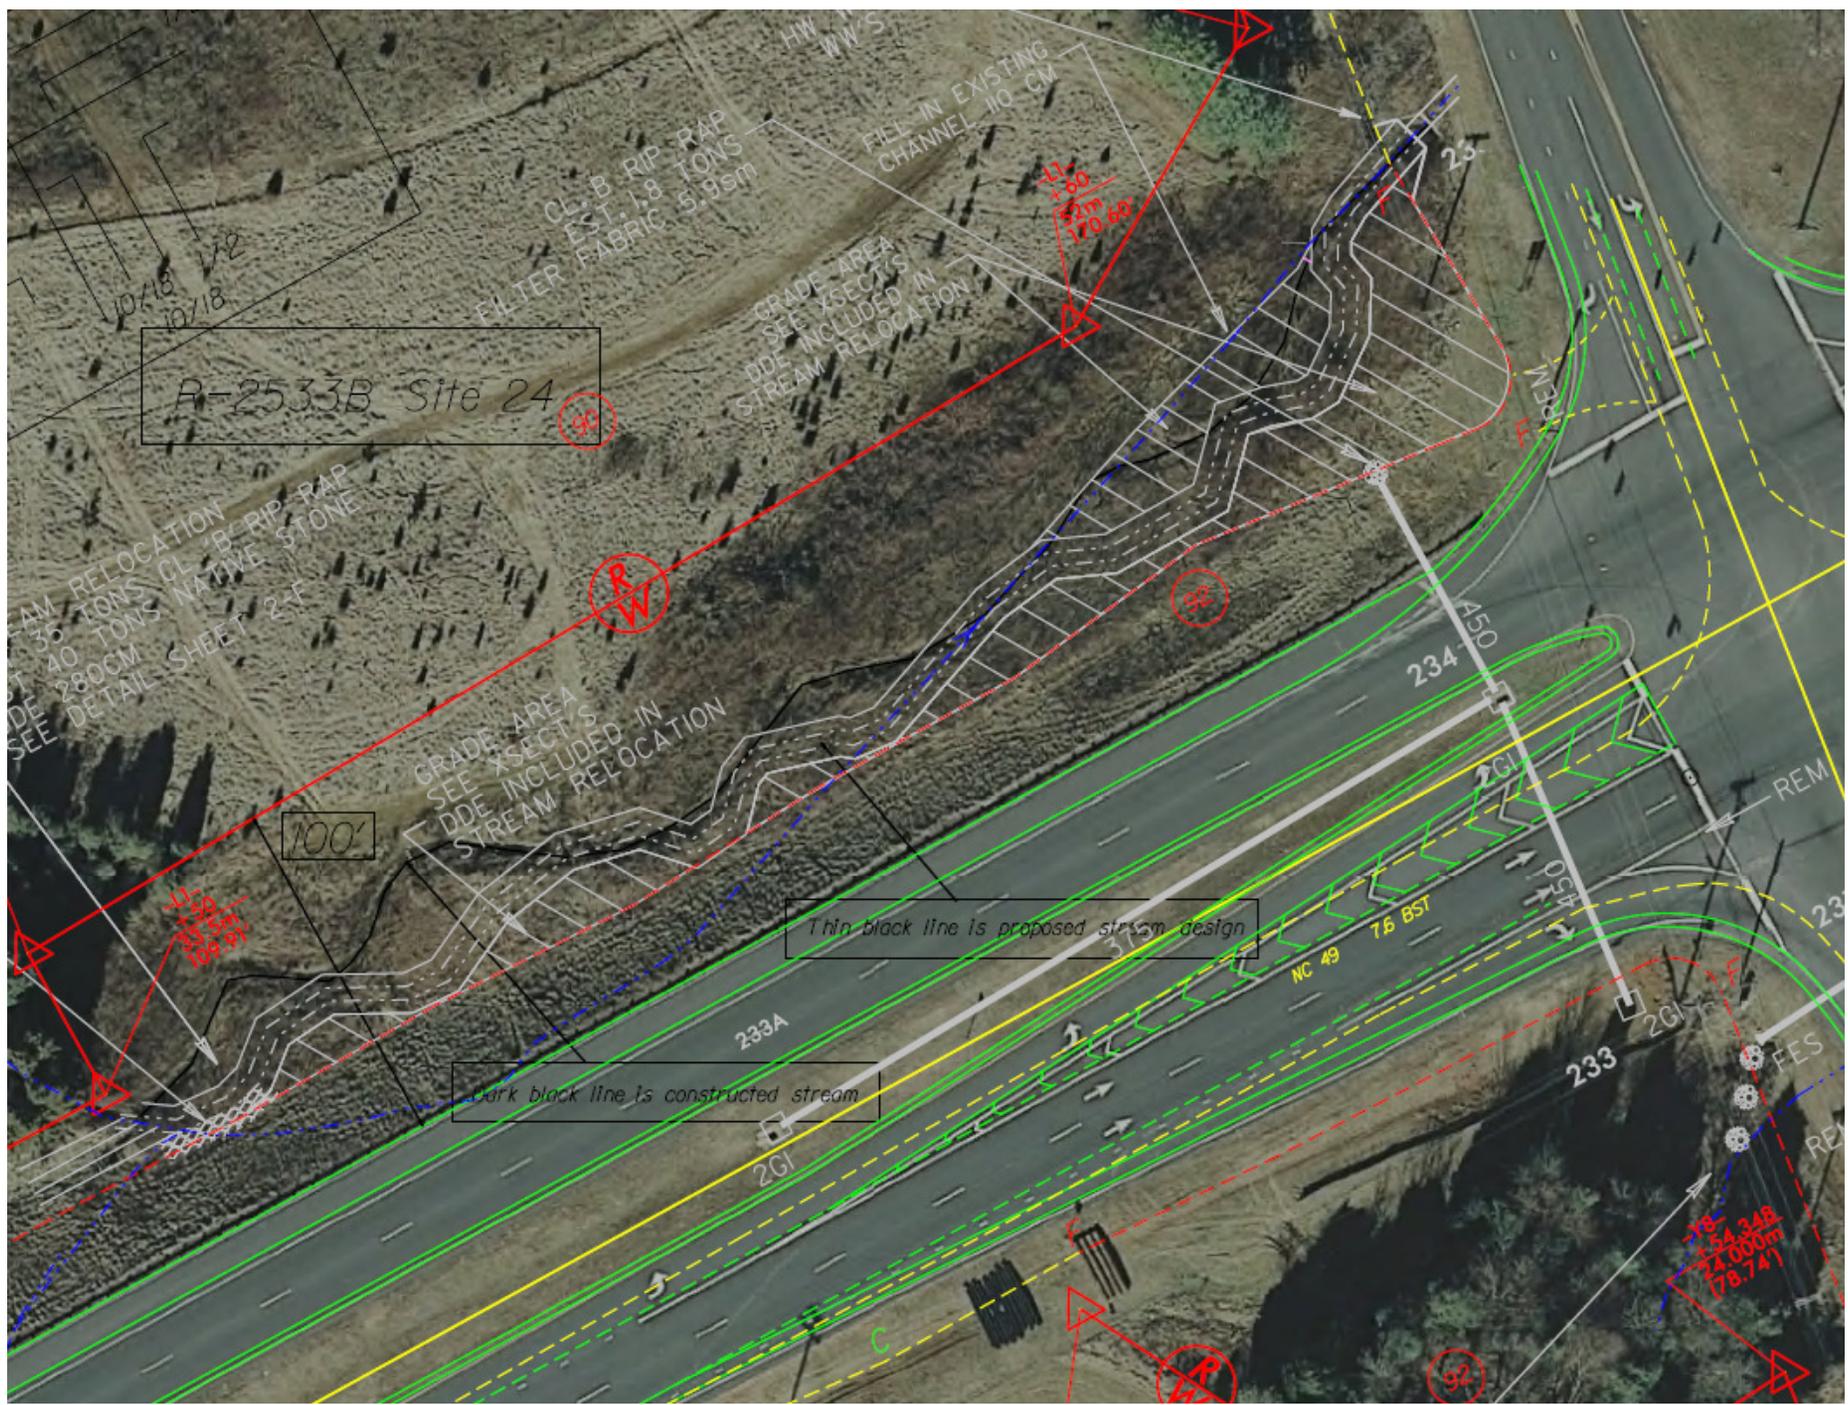
**CONSTRUCTED RELOCATION VS.
PROPOSED PLAN DESIGN**

The attached figure shows the constructed relocation overlaid over the proposed plan design (See Appendix C for the plan design and Appendix D for permit conditions). The permit states that 525 LF of relocation is required. The proposed plan measures 539.2 LF and the constructed relocation measures to 522.5 LF. The constructed relocation differs from the proposed plan design, but it appears it was shifted during construction to “center” the stream within the floodplain section. The original design shows some meander sections abutting the proposed toe of slope.

This plan view also shows the R/W that was acquired in order to perform the stream relocation. This R/W line extends approximately 100’ from the shoulder point of the roadway. It is the same R/W as depicted in the attached permit drawing. The permit conditions state that vegetation used for bank stabilization should include “establishment of a 30-foot wide wooded and an adjacent 20-foot wide vegetated buffer on both sides of the relocated channel to the maximum extent practical”. While there is not a 50’ buffer throughout on both sides of the stream, there is a continuous vegetated buffer within the R/W that was purchased to perform the stream relocation and as depicted on the approved permit drawings. There is one area with sparse woody vegetation along the floodplain but a stem count taken at the site showed an average of 408 stems per acre.
