# ANNUAL REPORT FOR 2012

**Holland Creek Site M Mitigation Site**  
**Madison County**  
**TIP No. R-2518A**  
**COE Action ID: SAW-2007-2197-357/300**  
**DWQ #: 20071134**

Prepared By:  
Natural Environment Section & Roadside Environmental Unit  
North Carolina Department of Transportation  
December 2012

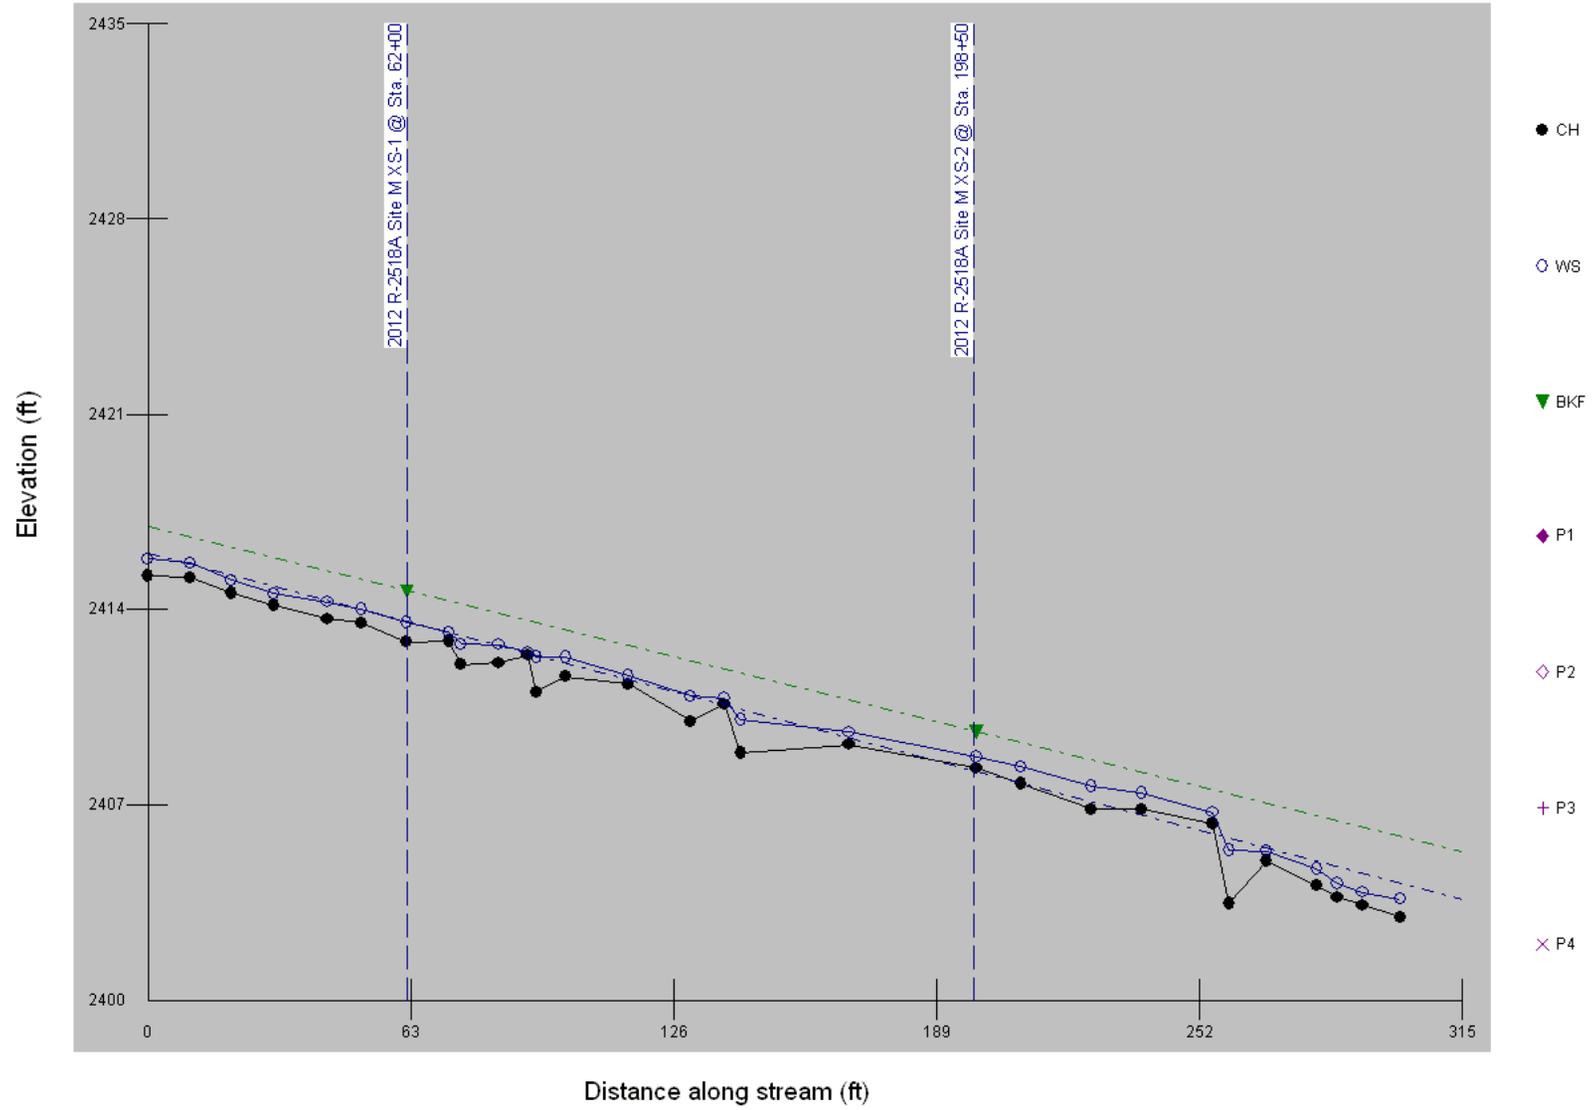
# R-2518A Site M Profile

Based on comparisons of the As-Built to the monitoring data, all of the cross sections appear stable with little or no active bank erosion. Graphs of the cross sections are presented in Appendix A. Future survey data will vary depending on actual location of rod placement and alignment; however, this information should remain similar in appearance. The longitudinal profile showed that the channel was stable for the 2012 monitoring evaluation. Pebble counts were not required per the permit conditions and therefore were not completed.
